General Information

Make	Toyota	Model	Vios
YOM	2023	Odo Meter Reading	16,464
Registration No.	NHJ4608	Chassis No.	PA1B18F38P4211816
CC	1.3	Transmission	CVT
Fuel Type	Gas	Type of Body	Sedan
Colour	Green

Body / Panel Condition

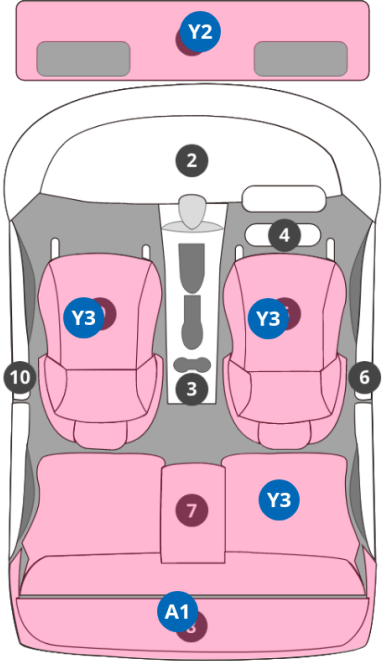
Interior Evaluation : B	Exterior Evaluation : C

<p>a : Cut, Fray d : Loose, Deformed k : Animal Hair s : Smell t : Cigarette Burns x : Defective y : Stain</p>

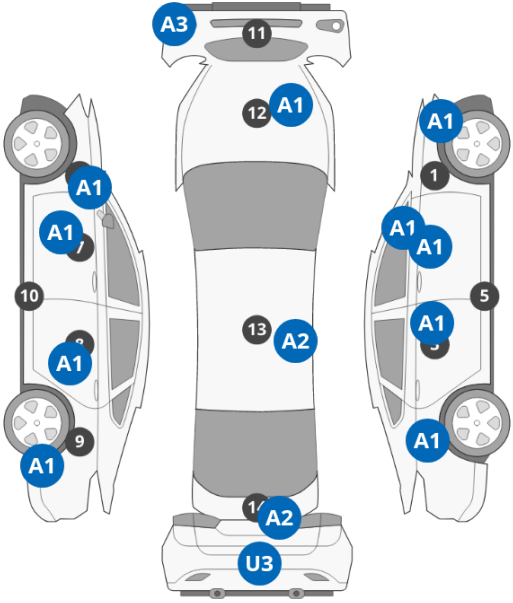
<p>A : Scratch AU : Scratch & Dent B : Modified C : Corrosion G : Stone chip P : Faded S : Rust SC : Rust & Corrosion U : Dent X : Defective Y : Crack, Gap</p>
<p>Remarks Ceiling - Grime - Small / (R) Front Seat - Grime - Medium / Rear Seat - Grime - Medium / Trunk Room - Worn, Scratch, Cut, Crack - Minimal / (L) Front Seat - Grime - Medium</p>	<p>Remarks Front Bumper, Grille, Lamps - Scratch - Medium / Rear Bumper, Lamps, Panels - Dent - Medium / (R) Mirror - Scratch - Minimal / (R) Front Fender, Molding - Scratch - Minimal / Bonnet, Headlight - Scratch - Minimal / (R) Front Door, Molding - Scratch - Minimal / (R) Rear Door, Molding - Scratch - Minimal / Roof - Scratch - Small / (R) Rear Fender, Molding - Scratch - Minimal / Trunk Hood, Rear Gate - Scratch - Small / (L) Rear Door, Molding - Scratch - Minimal / (L) Front Door, Molding - Scratch - Minimal / (L) Front Fender, Molding - Scratch - Minimal / (L) Rear Fender, Molding - Scratch - Minimal</p>
