General Information

Make	Toyota	Model	Lite Ace
YOM	2023	Odo Meter Reading	22,298
Registration No.	BAF6329	Chassis No.	MHKB3FE10NK001415
CC	1.5	Transmission	M/T
Fuel Type	Gas	Type of Body	Van
Colour	White

Body / Panel Condition

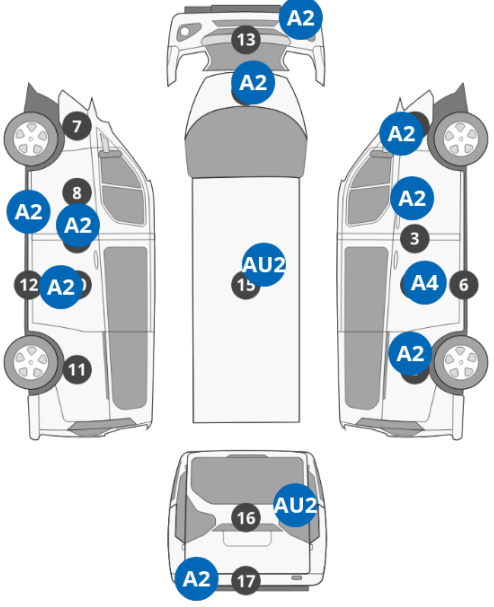
<p>A : Scratch AU : Scratch & Dent B : Modified C : Corrosion G : Stone chip P : Faded S : Rust SC : Rust & Corrosion U : Dent X : Defective Y : Crack, Gap</p>
<p>Remarks Ceiling - Grime - Large / Carpet - Worked - Large / Mat Other - Worked - Large / Overall Interior - Smell - Yes / (R) Front Floor Mat - Worked - Small / (L) Front Floor Mat - Worked - Small / Dashboard - Worked - Minimal / (R) Front Seat - Grime - Small / (L) Front Seat - Grime - Small</p>	<p>Remarks Trunk Hood, Rear Gate - Scratch & Dent - Small / (R) Rear Fender, Molding - Scratch - Small / (R) Rear Door, Molding - Scratch - Large / Rear Bumper, Lamps, Panels - Scratch - Small / (L) Front Door, Molding - Scratch - Small / (L) Step, In-panel, Side Spoiler - Scratch - Small / (L) Rear Door, Molding - Scratch - Small / Bonnet, Headlight - Scratch - Small / Front Bumper, Grille, Lamps - Scratch - Small / (R) Front Door, Molding - Scratch - Small / Roof Spoiler, Molding - Scratch & Dent - Small / (R) Front Fender, Molding - Scratch - Small</p>
