General Information

Date & Time: 23, May, 2025 10:58

Make	Hyundai	Model	Stargazer
YOM	2023	Mileage	61,755
Registration No.	NIN5817	Chassis No.	MF3NB81DEPJ009009
CC	1.5	Transmission	A/T
Fuel Type	Gas	Type of Body	MPV
Colour	Black

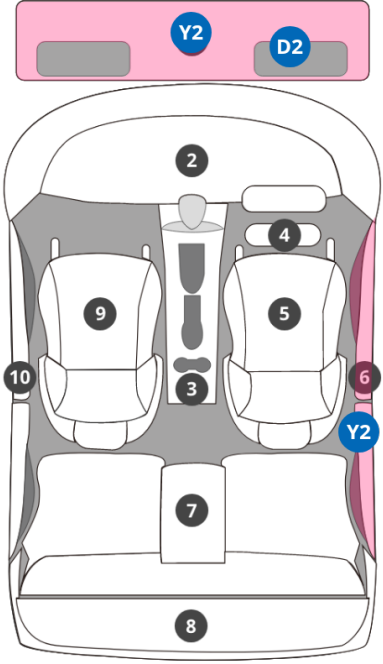
<p>a : Cut, Fray d : Loose, Deformed k : Animal Hair s : Smell t : Cigarette Burns x : Defective y : Stain</p>

<p>A : Scratch AU : Scratch & Dent B : Modified C : Corrosion G : Stone chip P : Faded S : Rust SC : Rust & Corrosion U : Dent X : Defective Y : Crack, Gap</p>
<p>Remarks Ceiling - Grime - Small / Sunvisor, Sunglass Holder - Crinkle - Small / (R) Rear Trim - Grime - Small</p>	<p>Remarks (L) Rear Door, Molding - Repair mark - Yes / (L) Rear Fender, Molding - Repair mark - Yes / (L) Rear Fender, Molding - Scratch - Large / (L) Rear Door, Molding - Scratch - Medium / (L) Front Door, Molding - Scratch - Small / (L) Mirror - Scratch - Small / (L) Front Fender, Molding - Scratch - Small / (R) Rear Fender, Molding - Scratch - Small / (R) Front Door, Molding - Scratch - Small / Rear Bumper, Lamps, Panels - Repair mark - Yes / Rear Bumper, Lamps, Panels - Scratch - Medium / Roof - Dent - Minimal / Front Bumper, Grille, Lamps - Dent - Small</p>
