## General Information

| Make | Toyota | Model | Vios |

## Body / Panel Condition

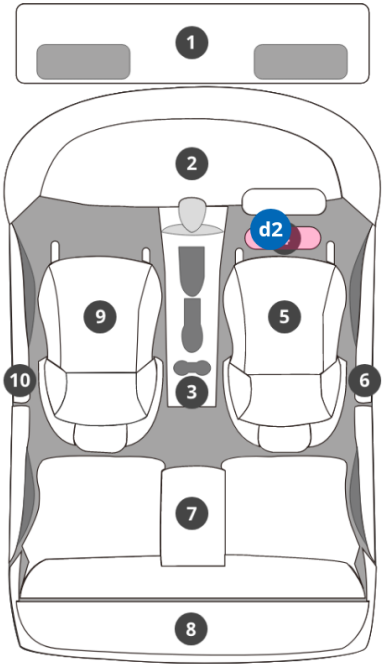
| <b>Interior Evaluation :</b> <span style="color: red; font-weight: bold;">A</span> | <b>Exterior Evaluation :</b> <span style="color: red; font-weight: bold;">A</span> |
| <b>Remarks</b><br>(L) Front Floor Lag - Loose, Deformed, Grime - Small | <b>Remarks</b><br>Front Bumper, Grille, Lamps - Scratch & Dent - Small / Bonnet, Headlight - Scratch - Minimal / (R) Front Door, Molding - Scratch - Minimal / (R) Rear Door, Molding - Scratch - Minimal / (R) Rear Fender, Molding - Scratch - Minimal / Trunk Hood, Rear Gate - Scratch - Minimal / Roof - Scratch - Minimal |

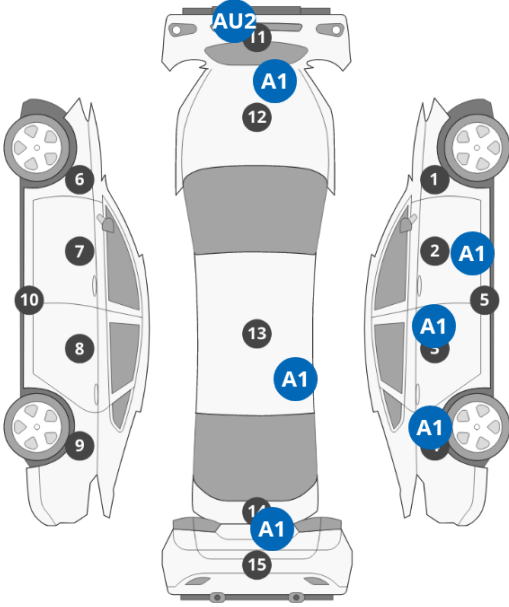
| Inspector Notes |
|---|
| hairline scratches and swirl marks |
