## General Information

| Make | Toyota | Model | Rush |

## Body / Panel Condition

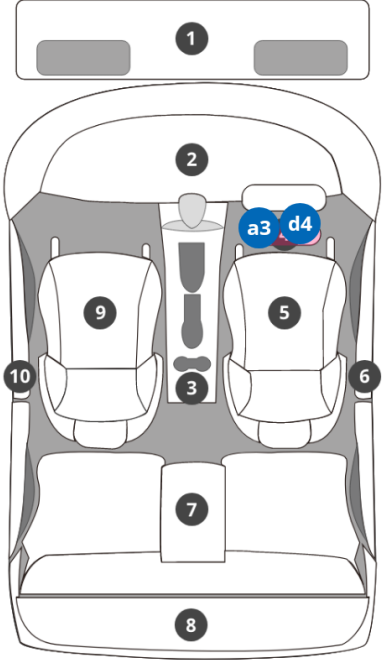
| Interior Evaluation : <b>B</b> | Exterior Evaluation : <b>B</b> |
| <b>Remarks</b><br>(L) Front Floor Lag - Cut, Crack - Medium | <b>Remarks</b><br>(R) Rear Fender, Molding - Scratch - Small / Rear Bumper, Lamps, Panels - Scratch - Minimal / (R) Step, In-panel, Side Spoiler - Scratch - Medium |

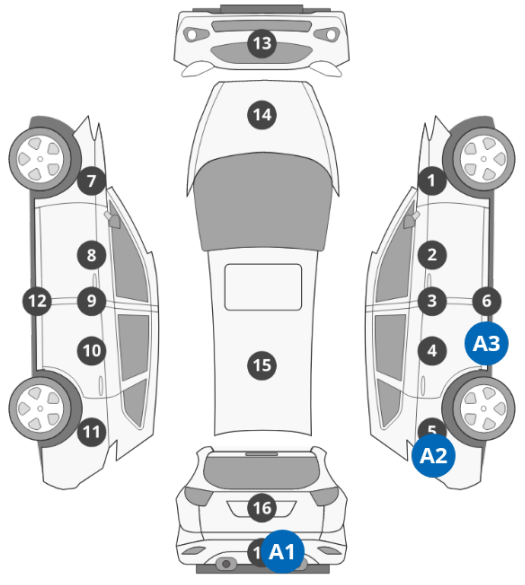
rock chips present/ hairline scratches and swirl marks present/ worn floor matts
