General Information

Make	Toyota	Model	Alphard
YOM	2025	Mileage	3
Registration No.	DA234B	Chassis No.	JTNACAAH1S8011952
CC	2.5	Transmission	CVT
Fuel Type	Gas	Type of Body	Van
Colour	White

Body / Panel Condition

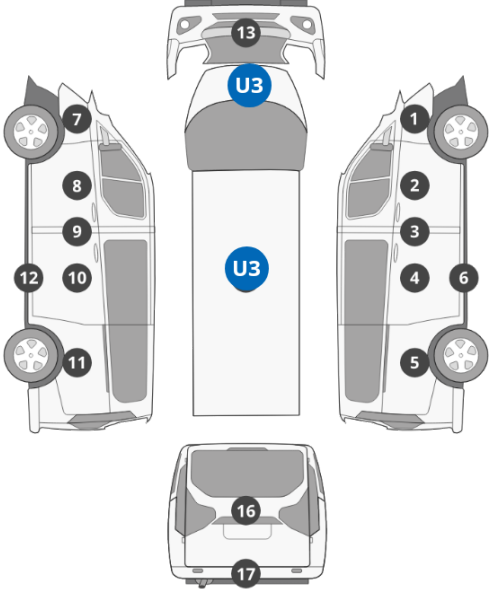
<p>A : Scratch AU : Scratch & Dent B : Modified C : Corrosion G : Stone chip P : Faded S : Rust SC : Rust & Corrosion U : Dent X : Defective Y : Crack, Gap</p>
Remarks Defects not found	Remarks Bonnet, Headlight - Dent - Medium / Roof - Dent - Medium
Frame Evaluation : A	Functional Evaluation : A
Remarks Defects not found	Remarks Defects not found

Inspector Notes
cluster of dents on roof and hood
