## General Information

| <b>Make</b> | Toyota | <b>Model</b> | Vios |
| <b>YOM</b> | 2023 | <b>Odo Meter Reading</b> | 51,385 |
| <b>Registration No.</b> | NFE5553 | <b>Chassis No.</b> | PA1B18F36P4222751 |

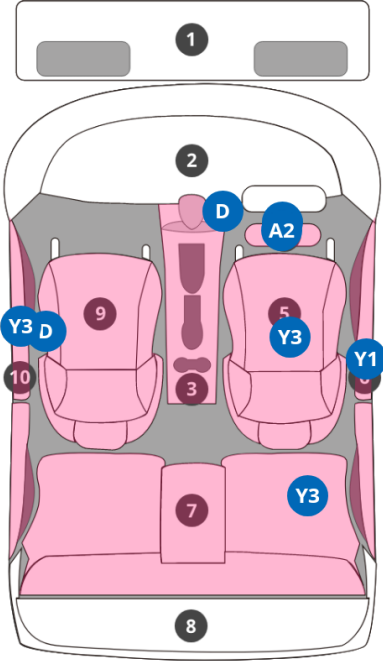
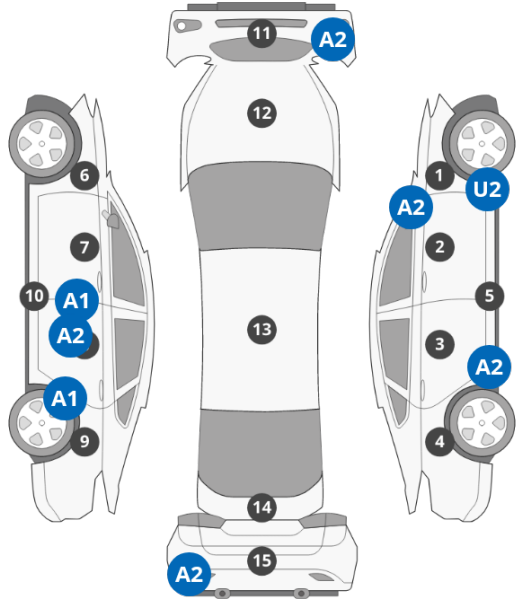
| <b>Interior Evaluation :</b> <span style="float: right; color: red; font-weight: bold;">C</span> | <b>Exterior Evaluation :</b> <span style="float: right; color: red; font-weight: bold;">B</span> |

| <p><b>a</b> : Cut, Fray <b>d</b> : Loose, Deformed <b>k</b> : Animal Hair <b>s</b> : Smell <b>t</b> : Cigarette Burns <b>x</b> : Defective <b>y</b> : Stain</p> | <p><b>A</b> : Scratch <b>AU</b> : Scratch &amp; Dent <b>B</b> : Modified <b>C</b> : Corrosion <b>G</b> : Stone chip <b>P</b> : Faded <b>S</b> : Rust <b>SC</b> : Rust &amp; Corrosion <b>U</b> : Dent <b>X</b> : Defective <b>Y</b> : Crack, Gap</p> |
| <p><b>Remarks</b><br/>Rear Seat - Grime - Medium / (R) Front Seat - Grime - Medium / (L) Front Seat - Worn - Yes / (R) Front Trim - Grime - Minimal / (L) Front Trim - Grime - Medium / (L) Front Floor Mat - Worked - Large / (L) Front Floor Mat - Cut, Crack - Small / Console, Switches, Vents - Traces of Adhesive Tape - Yes</p> | <p><b>Remarks</b><br/>(R) Mirror - Scratch - Small / (R) Front Fender, Molding - Dent - Small / (R) Step, In-panel, Side Spoiler - Scratch - Small / Rear Bumper, Lamps, Panels - Scratch - Small / (L) Rear Fender, Molding - Scratch - Minimal / (L) Front Door, Molding - Scratch - Minimal / (L) Rear Door, Molding - Scratch - Small / Front Bumper, Grille, Lamps - Scratch - Small</p> |
