General Information

Make	Toyota	Model	Avanza
YOM	2023	Odo Meter Reading	53,395
Registration No.	NHC5504	Chassis No.	MHFAA1BY2N0009207
CC	1.3	Transmission	M/T
Fuel Type	Gas	Type of Body	MPV
Colour	Silver

Body / Panel Condition

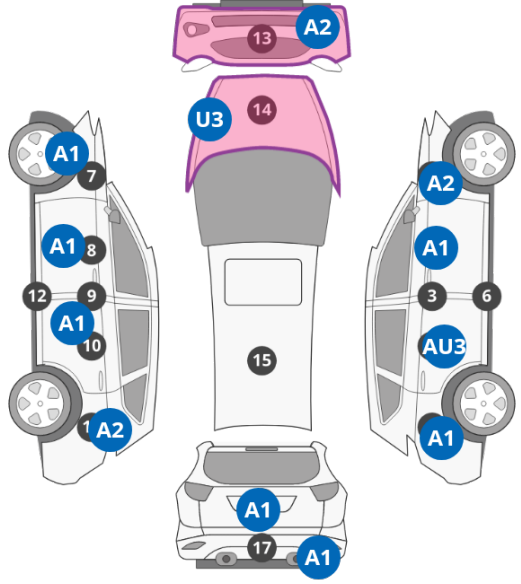
<p>A : Scratch AU : Scratch & Dent B : Modified C : Corrosion G : Stone chip P : Faded S : Rust SC : Rust & Corrosion U : Dent X : Defective Y : Crack, Gap</p>
Remarks Overall Interior - Worn as per age - Yes	Remarks Bonnet - Repair Traces - Yes / (L) Front Fender - Repair Traces - Yes / Front Bumper, Grille, Lamps - Repair mark - Yes / Bonnet, Headlight - Dent - Medium / Bonnet, Headlight - Repair mark - Yes / (R) Rear Door, Molding - Scratch & Dent - Medium / Front Bumper, Grille, Lamps - Scratch - Small / (L) Rear Fender, Molding - Scratch - Small / (R) Front Door, Molding - Scratch - Minimal / (L) Rear Door, Molding - Scratch - Minimal / Trunk Hood, Rear Gate - Scratch - Minimal / (L) Front Door, Molding - Scratch - Minimal / (L) Front Fender, Molding - Scratch - Minimal / (R) Front Fender, Molding - Scratch - Small / Rear Bumper, Lamps, Panels - Scratch - Minimal / (R) Rear Fender, Molding - Scratch - Minimal
