General Information

| Make | Toyota | Model | Vios |

Body / Panel Condition

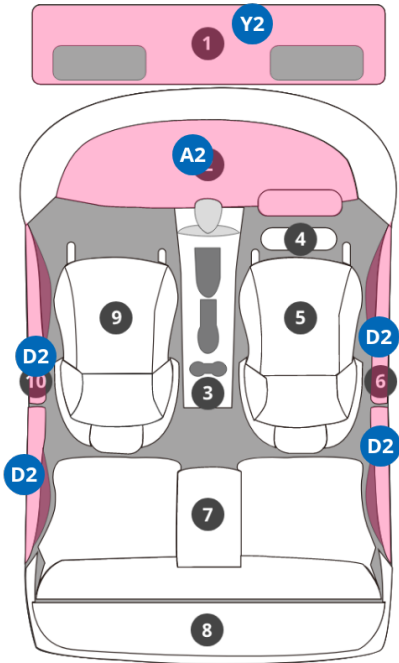
| Interior Evaluation : C | Exterior Evaluation : E |
| <p>Remarks Overall Interior - Worn as per age - Yes / Ceiling - Grime - Small / Steering Wheel - Worn, Peel, Crack - Small / (L) Front Trim - Worked - Small / (R) Front Trim - Worked - Small / (L) Rear Trim - Worked - Small / (R) Rear Trim - Worked - Small</p> | <p>Remarks (R) Step - Repair Traces - Yes / (R) Front Fender - Repair Traces - Yes / Bonnet - Repair Traces - Yes / (L) Front Fender - Repair Traces - Yes / (L) Front Door - Repair Traces - Yes / (L) Rear Door - Repair Traces - Yes / (L) Rear Fender - Repair Traces - Yes / Trunk Hood, Rear Gate - Repair Traces - Yes / (R) Rear Fender - Repair Traces - Yes / Trunk Hood, Rear Gate - Scratch & Dent - Medium / (R) Step, In-panel, Side Spoiler - Repair mark - Yes / (R) Front Fender, Molding - Repair mark - Yes / Bonnet, Headlight - Repair mark - Yes / (R) Rear Fender, Molding - Repair mark - Yes / Trunk Hood, Rear Gate - Repair mark - Yes / (L) Rear Fender, Molding - Repair mark - Yes / (L) Rear Door, Molding - Repair mark - Yes / (L) Front Door, Molding - Repair mark - Yes / (L) Front Fender, Molding - Repair mark - Yes / Rear Bumper, Lamps, Panels - Repair mark - Yes / Rear Bumper, Lamps, Panels - Scratch - Minimal / (L) Rear Door, Molding - Dent - Small / (L) Side Window - Scratch, Stone chip - Small / (L) Front Fender, Molding - Dent - Small / Front Bumper, Grille, Lamps - Scratch - Small / (R) Side Window - Scratch, Stone chip - Small / (R) Step, In-panel, Side Spoiler - Scratch & Dent - Small / (R) Front Fender, Molding - Scratch - Small / (R) Front Door, Molding - Scratch - Small / (R) Rear Door, Molding - Scratch & Dent - Small / (R) Rear Fender, Molding - Scratch - Minimal / Roof - Scratch & Dent - Small / Bonnet, Headlight - Scratch - Small</p> |
