General Information

Make	Toyota	Model	Vios
YOM	2024	Odo Meter Reading	32,026
Registration No.	NFS4186	Chassis No.	PA1B18F34P4234378
CC	1.3	Transmission	CVT
Fuel Type	Gas	Type of Body	Sedan
Colour	Red Mica Metallic

Body / Panel Condition

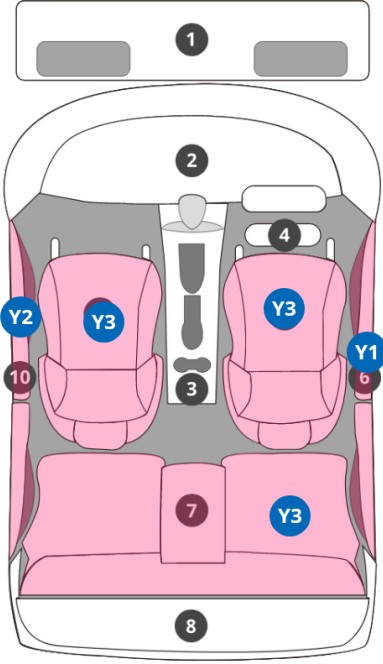
Interior Evaluation : B	Exterior Evaluation : E

<p>a : Cut, Fray d : Loose, Deformed k : Animal Hair s : Smell t : Cigarette Burns x : Defective y : Stain</p>

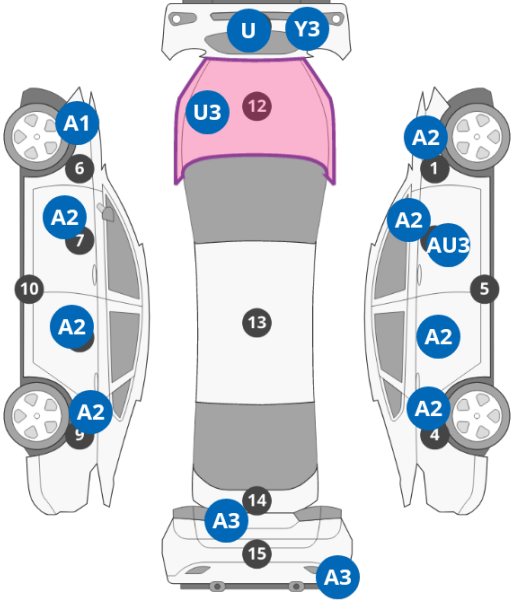
<p>A : Scratch AU : Scratch & Dent B : Modified C : Corrosion G : Stone chip P : Faded S : Rust SC : Rust & Corrosion U : Dent X : Defective Y : Crack, Gap</p>
<p>Remarks Rear Seat - Grime - Medium / (R) Front Seat - Grime - Medium / (L) Front Seat - Grime - Medium / (R) Front Trim - Grime - Minimal / (L) Front Trim - Grime - Small</p>	<p>Remarks Bonnet, Headlight - Repair mark - Difference in Color / (R) Mirror - Scratch - Small / (R) Front Fender, Molding - Scratch - Small / (R) Rear Door, Molding - Scratch - Small / (R) Front Door, Molding - Scratch & Dent - Medium / (R) Rear Fender, Molding - Scratch - Small / Rear Bumper, Lamps, Panels - Scratch - Medium / Trunk Hood, Rear Gate - Scratch - Medium / (L) Rear Fender, Molding - Scratch - Small / (L) Rear Door, Molding - Scratch - Small / (L) Front Door, Molding - Scratch - Small / (L) Front Fender, Molding - Scratch - Minimal / Member (Bolted) - Dent - Yes / Front Bumper, Grille, Lamps - Crack, Gap - Medium / Bonnet, Headlight - Dent - Medium</p>
