## General Information

| Make | Toyota | Model | Vios |
| YOM | 2024 | Mileage | 13,117 |
| Registration No. | BAF7876 | Chassis No. | PA1B18F30P4238041 |

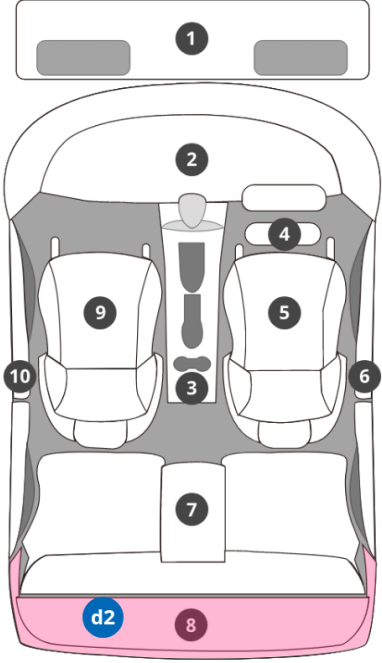
| <b>Remarks</b><br>Trunk Room - Loose, Deformed, Grime - Small | <b>Remarks</b><br>Front Bumper, Grille, Lamps - Scratch - Small / Rear Bumper, Lamps, Panels - Scratch - Small |

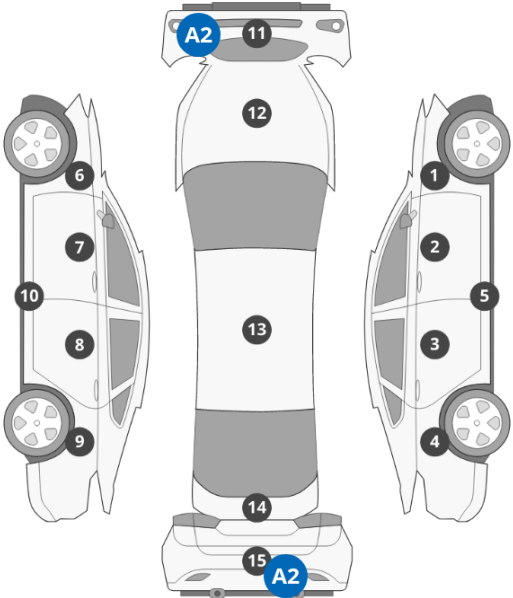
| Inspector Notes |
|---|
| reverse camera not aligned/ hairline scratches and swirl marks present/ very good condition |
