General Information

Make	Toyota	Model	Avanza
YOM	2024	Odo Meter Reading	7,489
Registration No.	NHS2907	Chassis No.	MHFAA1BY8R0026289
CC	1.3	Transmission	M/T
Fuel Type	Gas	Type of Body	MPV
Colour	Black

Body / Panel Condition

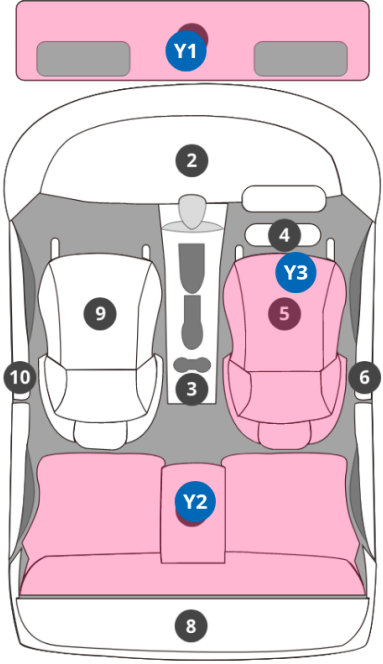
Interior Evaluation : B	Exterior Evaluation : B

<p>a : Cut, Fray d : Loose, Deformed k : Animal Hair s : Smell t : Cigarette Burns x : Defective y : Stain</p>

<p>A : Scratch AU : Scratch & Dent B : Modified C : Corrosion G : Stone chip P : Faded S : Rust SC : Rust & Corrosion U : Dent X : Defective Y : Crack, Gap</p>
Remarks Rear Seat - Grime - Small / Ceiling - Grime - Minimal / (R) Front Seat - Grime - Medium	Remarks (R) Front Fender, Molding - Rust, Corrosion - Small / (R) Front Door, Molding - Scratch - Minimal / (R) Rear Door, Molding - Scratch - Minimal / (R) Rear Fender, Molding - Scratch - Minimal / Rear Bumper, Lamps, Panels - Scratch - Small / Trunk Hood, Rear Gate - Scratch - Minimal / (L) Rear Fender, Molding - Scratch - Minimal / (L) Rear Door, Molding - Scratch - Minimal / (L) Step, In-panel, Side Spoiler - Scratch - Small / (L) Front Fender, Molding - Scratch - Minimal / Roof - Scratch - Minimal / Front Bumper, Grille, Lamps - Scratch - Minimal / Bonnet, Headlight - Scratch - Minimal
