General Information

Make	Toyota	Model	Vios
YOM	2024	Odo Meter Reading	33,107
Registration No.	NFR7655	Chassis No.	PA1B18F34R4256884
CC	1.3	Transmission	CVT
Fuel Type	Gas	Type of Body	Sedan
Colour	Blue

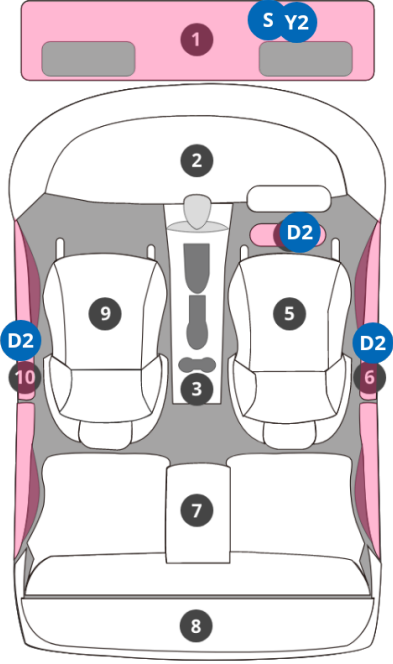
Interior Evaluation : B	Exterior Evaluation : C

<p>a : Cut, Fray d : Loose, Deformed k : Animal Hair s : Smell t : Cigarette Burns x : Defective y : Stain</p>

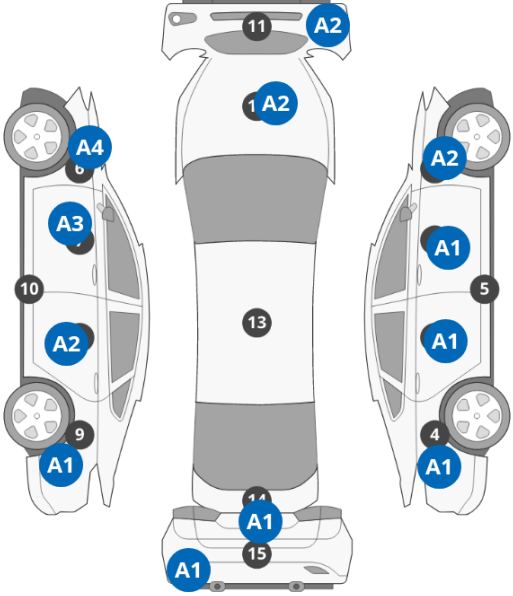
<p>A : Scratch AU : Scratch & Dent B : Modified C : Corrosion G : Stone chip P : Faded S : Rust SC : Rust & Corrosion U : Dent X : Defective Y : Crack, Gap</p>
<p>Remarks Overall Interior - Smell - Yes / Ceiling - Grime - Small / (L) Front Floor Mat - Worked - Small / (L) Front Trim - Worked - Small / (R) Front Trim - Worked - Small</p>	<p>Remarks (R) Rear Fender - Repair Traces - Yes / (L) Front Door, Molding - Scratch - Medium / (L) Front Fender, Molding - Scratch - Large / (L) Rear Door, Molding - Scratch - Small / (L) Rear Fender, Molding - Scratch - Minimal / Rear Bumper, Lamps, Panels - Scratch - Minimal / Trunk Hood, Rear Gate - Scratch - Minimal / Bonnet, Headlight - Scratch - Small / Front Bumper, Grille, Lamps - Scratch - Small / (R) Front Fender, Molding - Scratch - Small / (R) Front Door, Molding - Scratch - Minimal / (R) Rear Door, Molding - Scratch - Minimal / (R) Rear Fender, Molding - Scratch - Minimal</p>
