General Information

Make	Toyota	Model	Vios
YOM	2024	Odo Meter Reading	10,379
Registration No.	DBO6969	Chassis No.	PA1B18F3XR4256579
CC	1.3	Transmission	CVT
Fuel Type	Gas	Type of Body	Sedan
Colour	Red

Body / Panel Condition

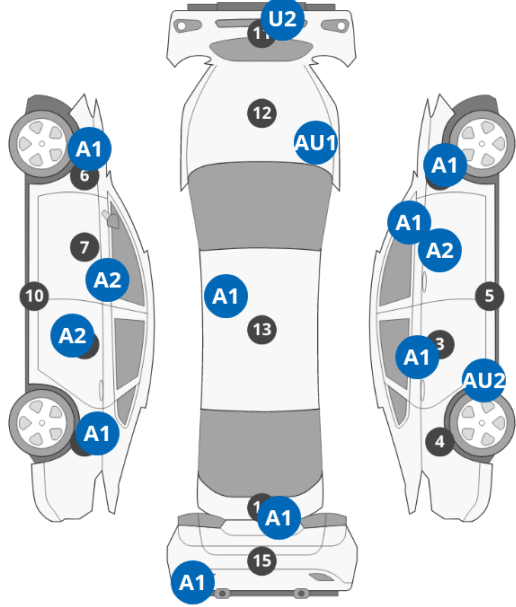
</div> <p>A : Scratch AU : Scratch & Dent B : Modified C : Corrosion G : Stone chip P : Faded S : Rust SC : Rust & Corrosion U : Dent X : Defective Y : Crack, Gap</p>
<p>Remarks Trunk Room - Worn, Scratch, Cut, Crack - Minimal / Rear Seat - Grime - Medium / (R) Front Seat - Grime - Large / Mat Other - Missing - Yes / (R) Front Floor Mat - Missing - Yes / (L) Front Floor Mat - Missing - Yes</p>	<p>Remarks (R) Front Fender, Molding - Scratch - Minimal / (R) Mirror - Scratch - Minimal / (R) Front Door, Molding - Scratch - Small / (R) Rear Door, Molding - Scratch - Minimal / (R) Rear Fender, Molding - Scratch & Dent - Small / Rear Bumper, Lamps, Panels - Scratch - Minimal / Trunk Hood, Rear Gate - Scratch - Minimal / (L) Rear Fender, Molding - Scratch - Minimal / (L) Rear Door, Molding - Scratch - Small / (L) Front Door, Molding - Scratch - Small / Roof - Scratch - Minimal / (L) Front Fender, Molding - Scratch - Minimal / Front Bumper, Grille, Lamps - Dent - Small / Bonnet, Headlight - Scratch & Dent - Minimal</p>
