## General Information

| Make | Toyota | Model | Vios |
| Registration No. | NIS1154 | Chassis No. | PA1B18F32P4224691 |

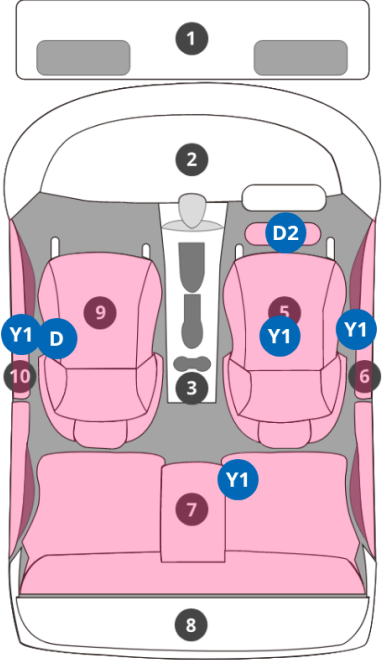
| Interior Evaluation : <b>B</b> | Exterior Evaluation : <b>B</b> |
|---|---|
| <p><b>Remarks</b></p> <p>Rear Seat - Grime - Minimal / (R) Front Trim - Grime - Minimal / (R) Front Seat - Grime - Minimal / (L) Front Floor Mat - Worked - Small / (L) Front Trim - Grime - Minimal / (L) Front Seat - Worn - Yes</p> | <p><b>Remarks</b></p> <p>(R) Front Door, Molding - Scratch - Minimal / (R) Rear Door, Molding - Scratch - Minimal / Rear Bumper, Lamps, Panels - Scratch - Small / Trunk Hood, Rear Gate - Dent - Minimal / (L) Front Door, Molding - Scratch - Small / (L) Front Fender, Molding - Scratch - Small / Front Bumper, Grille, Lamps - Scratch - Minimal / (L) Rear Door, Molding - Scratch - Minimal / (L) Rear Fender, Molding - Scratch &amp; Dent - Minimal</p> |
