## General Information

| Make | Toyota | Model | Hiace |
| Registration No. | DAP1491 | Chassis No. | JTFJT02P5M5027751 |

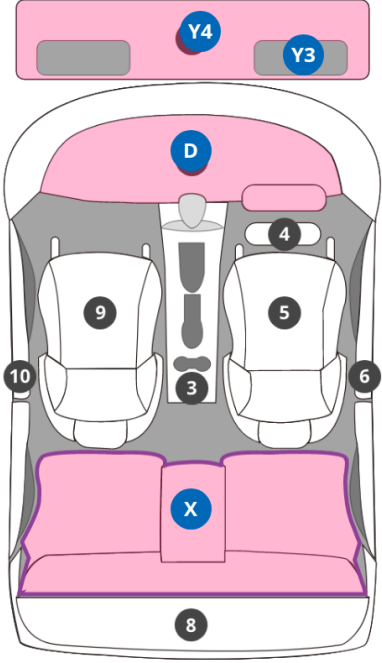
| <b>Interior Evaluation :</b> <span style="color: red; font-weight: bold;">C</span> | <b>Exterior Evaluation :</b> <span style="color: red; font-weight: bold;">D</span> |
| <b>Remarks</b><br>Sunvisor, Sunglass Holder - Grime - Medium / Ceiling - Grime - Large / Dashboard - Traces of Adhesive Tape - Yes / Rear Seat - Partially Missing - Yes | <b>Remarks</b><br>(R) Center Panel - Scratch - Small / (R) Mirror - Scratch - Small / Front Bumper, Grille, Lamps - Scratch & Dent - Large / Roof - Dent - Small / (R) Rear Door, Molding - Scratch & Dent - Large / (R) Rear Fender, Molding - Scratch - Small / Rear Bumper, Lamps, Panels - Scratch - Medium / (L) Rear Fender, Molding - Scratch - Small / (L) Mirror - Scratch - Small / (L) Front Fender, Molding - Scratch - Minimal / (L) Front Door, Molding - Scratch - Small / Bonnet, Headlight - Scratch - Minimal |
