## General Information

| Make | Toyota | Model | Fortuner |
| YOM | 2018 | Odo Meter Reading | 89,943 |
| Registration No. | NCC4116 | Chassis No. | MHFJB8GS6H1541732 |

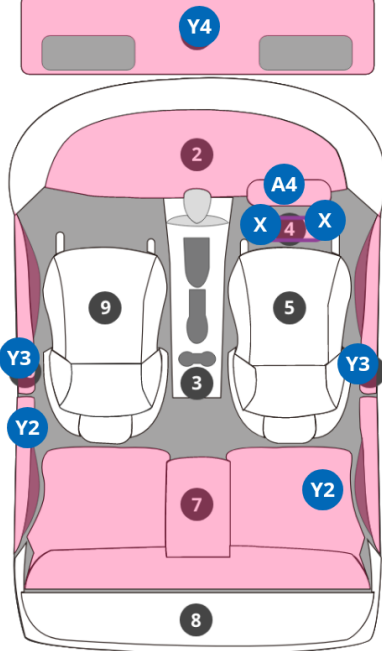
| Interior Evaluation : <b>C</b> | Exterior Evaluation : <b>E</b> |
| <p><b>Remarks</b></p> <p>Ceiling - Grime - Large / (R) Front Trim - Grime - Medium / Rear Seat - Grime - Small / (L) Rear Trim - Grime - Small / (L) Front Floor Mat - Missing - Yes / (R) Front Floor Mat - Missing - Yes / Steering Wheel - Worn, Peel, Crack - Large / (L) Front Trim - Grime - Medium</p> | <p><b>Remarks</b></p> <p>(L) Front Fender - Repair Traces - Yes / (L) Front Door - Repair Traces - Yes / (L) Rear Door, Molding - Scratch &amp; Dent - Medium / (L) Front Door, Molding - Scratch - Small / (L) Front Fender, Molding - Scratch - Small / Front Bumper, Grille, Lamps - Repair mark - Yes / Front Bumper, Grille, Lamps - Scratch - Small / Bonnet, Headlight - Scratch - Medium / (R) Front Fender, Molding - Scratch - Small / (R) Mirror - Scratch - Small / (R) Rear Door, Molding - Scratch &amp; Dent - Medium / (R) Front Door, Molding - Scratch &amp; Dent - Small / (R) Rear Fender, Molding - Scratch - Medium / Rear Bumper, Lamps, Panels - Scratch - Small / Trunk Hood, Rear Gate - Scratch &amp; Dent - Small / (L) Rear Fender, Molding - Scratch - Small / (L) Step, In-panel, Side Spoiler - Scratch - Minimal / Roof - Scratch - Medium</p> |
