## General Information

| Make | Toyota | Model | Hiace |
| YOM | 2024 | Odo Meter Reading | 28,946 |
| Registration No. | NIT1233 | Chassis No. | JTFJT02P5P0017903 |

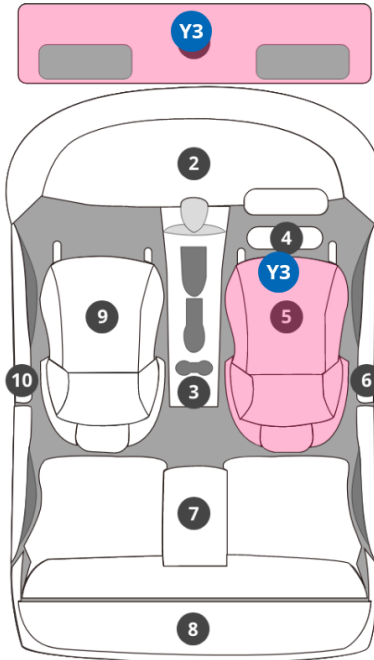
| Interior Evaluation : <span style="color: red; font-weight: bold;">B</span> | | Exterior Evaluation : <span style="color: red; font-weight: bold;">C</span> | |
|---|--|---|--|
| <p>Diagram showing the interior of a vehicle with numbered points (1-10) and defect codes (Y3, Y3, 5) indicating areas of concern.</p> | | <p>Diagram showing the exterior of a vehicle with numbered points (1-17) and defect codes (A2, A2, A3, AU2, A4, U2, A3) indicating areas of concern.</p> | |
| <p><b>Remarks</b></p> <p>(R) Front Seat - Grime - Medium / Ceiling - Grime - Medium</p> | | <p><b>Remarks</b></p> <p>(R) Mirror - Scratch - Small / (R) Step, In-panel, Side Spoiler - Scratch &amp; Dent - Small / (R) Rear Door, Molding - Scratch - Medium / (R) Rear Fender, Molding - Scratch &amp; Dent - Small / (L) Rear Fender, Molding - Repair mark - Yes / (L) Rear Fender, Molding - Scratch - Large / (L) Front Door, Molding - Scratch - Small / Front Bumper, Grille, Lamps - Scratch - Small / Rear Bumper, Lamps, Panels - Scratch - Medium / Roof - Dent - Small</p> | |
