## General Information

| Make | Toyota | Model | Hiace |
| Registration No. | NEE9730 | Chassis No. | JTFJT02P2P0016546 |

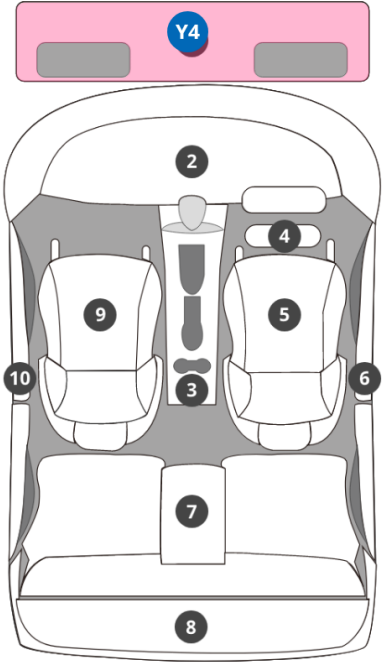
| Interior Evaluation : <span style="color: red;">C</span> | Exterior Evaluation : <span style="color: red;">D</span> |
| <b>Remarks</b><br>Ceiling - Grime - Large | <b>Remarks</b><br>(L) Rear Fender, Molding - Dent - Large / (L) Mirror - Scratch - Small / Bonnet, Headlight - Dent - Small / Front Bumper, Grille, Lamps - Scratch - Medium / (R) Front Door, Molding - Scratch & Dent - Small / (R) Mirror - Scratch - Minimal / (R) Center Panel - Scratch & Dent - Small / (R) Rear Fender, Molding - Scratch - Medium / (R) Rear Door, Molding - Scratch - Minimal / Trunk Hood, Rear Gate - Scratch & Dent - Small / Rear Bumper, Lamps, Panels - Scratch & Dent - Medium / Roof - Dent - Small / (L) Front Door, Molding - Scratch & Dent - Minimal |

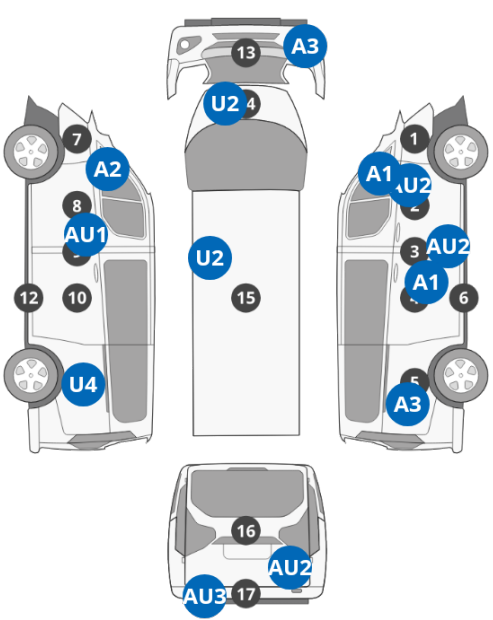
| Inspector Notes |
|---|
| Crack right taillight. With warranty booklet, jack and spare tire. Without tools. 1 key. With Lto plate. |
