## General Information

| Make | Nissan | Model | NV350 |

## Body / Panel Condition

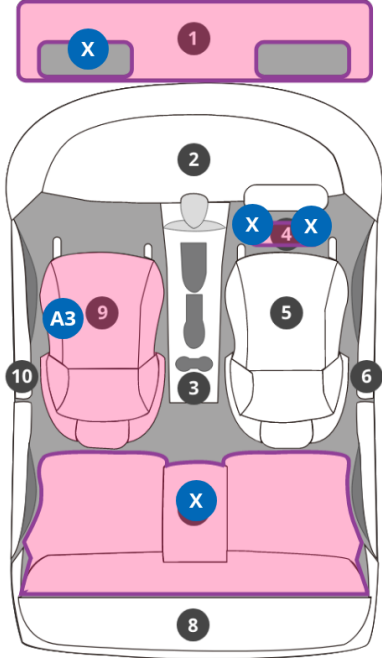
| Interior Evaluation : C | | Exterior Evaluation : C | |
| <b>Remarks</b><br>Rear Seat - Partially Missing - Yes / (R) Front Floor Mat - Missing - Yes / (L) Front Floor Mat - Missing - Yes / (L) Front Seat - Cut, Crack - Medium / Sunvisor, Sunglass Holder - Missing - Yes | | <b>Remarks</b><br>Bonnet, Headlight - Scratch & Dent - Small / Front Bumper, Grille, Lamps - Scratch - Large / (R) Rear Door, Molding - Scratch & Dent - Medium / Rear Bumper, Lamps, Panels - Scratch - Medium / (L) Rear Fender, Molding - Scratch - Small / (L) Mirror - Scratch - Small / (R) Mirror - Scratch - Small / Roof - Scratch & Dent - Large | |
