## General Information

<b>Make</b>	Honda	<b>Model</b>	Civic
<b>YOM</b>	2018	<b>Odo Meter Reading</b>	42,462
<b>Registration No.</b>	NCV2212	<b>Chassis No.</b>	MRHFC6630JT021301
<b>CC</b>	1.8	<b>Transmission</b>	CVT
<b>Fuel Type</b>	Gas	<b>Type of Body</b>	Sedan
<b>Colour</b>	White

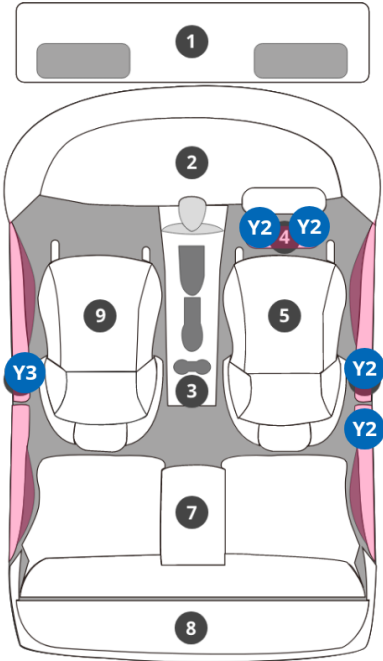
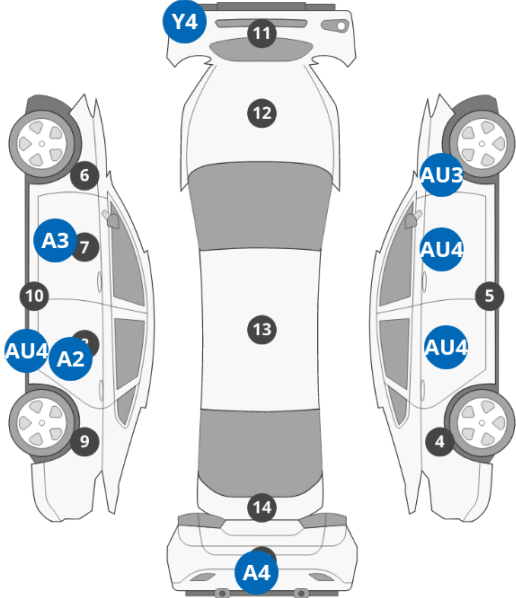
<b>Interior Evaluation :</b>	<b>B</b>	<b>Exterior Evaluation :</b>	<b>E</b>

<p><b>a</b> : Cut, Fray <b>d</b> : Loose, Deformed <b>k</b> : Animal Hair <b>s</b> : Smell <b>t</b> : Cigarette Burns <b>x</b> : Defective <b>y</b> : Stain</p>		<p><b>A</b> : Scratch <b>AU</b> : Scratch &amp; Dent <b>B</b> : Modified <b>C</b> : Corrosion <b>G</b> : Stone chip <b>P</b> : Faded <b>S</b> : Rust <b>SC</b> : Rust &amp; Corrosion <b>U</b> : Dent <b>X</b> : Defective <b>Y</b> : Crack, Gap</p>	
<p><b>Remarks</b> (R) Front Floor Mat - Grime - Small / (R) Front Trim - Grime - Small / (R) Rear Trim - Grime - Small / (L) Front Floor Mat - Grime - Small / (L) Front Trim - Grime - Medium</p>		<p><b>Remarks</b> Bonnet - Repair Traces - Yes / Trunk Hood, Rear Gate - Repair Traces - Yes / (R) Rear Door - Repair Traces - Yes / Roof - Repair Traces - Yes / (R) Rear Door, Molding - Scratch &amp; Dent - Large / (R) Front Door, Molding - Scratch &amp; Dent - Large / (R) Front Fender, Molding - Scratch &amp; Dent - Medium / Rear Bumper, Lamps, Panels - Scratch - Large / (L) Rear Door, Molding - Scratch - Small / (L) Step, In-panel, Side Spoiler - Scratch &amp; Dent - Large / Front Bumper, Grille, Lamps - Crack, Gap - Large / (L) Front Door, Molding - Scratch - Medium</p>
