## General Information

| Make | Toyota | Model | Hilux |
| Registration No. | ANA1851 | Chassis No. | MR0ER39G207641480 |

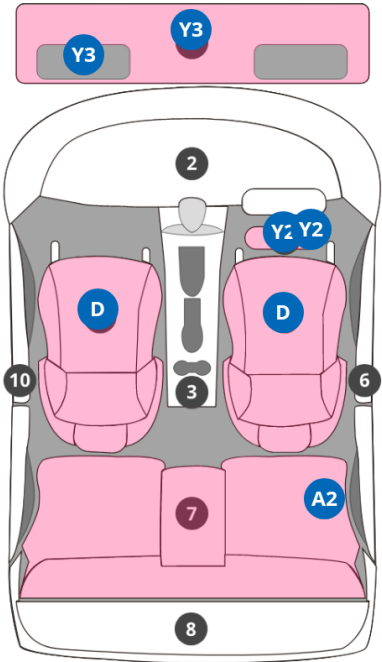
| Interior Evaluation : <span style="color: red;">C</span> | Exterior Evaluation : <span style="color: red;">E</span> |
| <p><b>Remarks</b></p> <p>Overall Interior - Worn as per age - Yes / Ceiling - Grime - Medium / (L) Front Seat - Worn - Yes / (R) Front Seat - Worn - Yes / Rear Seat - Cut, Crack - Small / Mat Other - Grime - Small / (R) Front Floor Mat - Grime - Small / Sunvisor, Sunglass Holder - Grime - Medium</p> | <p><b>Remarks</b></p> <p>(L) Side Gate - Scratch &amp; Dent - Large / (L) Side Gate - Repair mark - Yes / (L) Rear Door, Molding - Scratch - Large / (L) Front Door, Molding - Scratch - Large / (L) Front Fender, Molding - Scratch &amp; Dent - Large / Front Bumper, Grille, Lamps - Repair mark - Yes / Front Bumper, Grille, Lamps - Scratch &amp; Dent - Large / (R) Front Fender, Molding - Scratch &amp; Dent - Large / (R) Front Door, Molding - Scratch - Small / (R) Rear Door, Molding - Scratch - Small / (R) Rear Corner Panel - Scratch &amp; Dent - Medium / (R) Side Gate - Repair mark - Yes / (R) Side Gate - Scratch - Medium / Rear Bumper, Lamps, Panels - Scratch &amp; Dent - Large / Rear Gate - Scratch &amp; Dent - Small / Roof - Scratch &amp; Dent - Small / Cab Back Panel - Dent - Small / Bonnet, Headlight - Scratch - Small</p> |
