## General Information

| Make | Mitsubishi | Model | Lancer Ex |
| YOM | 2013 | Odo Meter Reading | 70,140 |
| Registration No. | UMQ932 | Chassis No. | PAECY1ASCCA000267 |

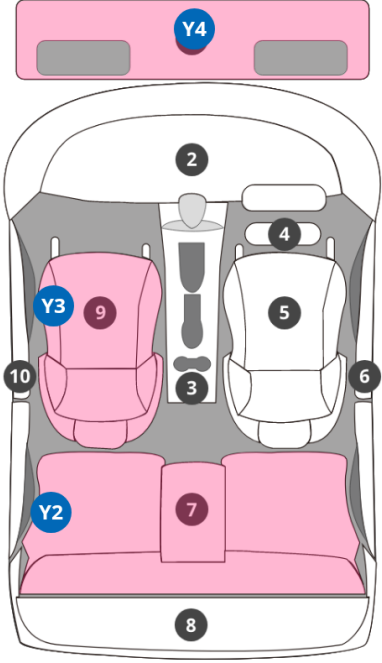
| <b>Interior Evaluation :</b> <span style="color: red; font-weight: bold;">C</span> | <b>Exterior Evaluation :</b> <span style="color: red; font-weight: bold;">C</span> |
| <b>Remarks</b><br>Ceiling - Grime - Large / Rear Seat - Grime - Small / (L) Front Seat - Grime - Medium | <b>Remarks</b><br>Bonnet - Repair Traces - Yes / (L) Front Fender - Repair Traces - Yes / Trunk Hood, Rear Gate - Repair Traces - Yes / (R) Rear Fender - Repair Traces - Yes / (R) Rear Door - Repair Traces - Yes / Roof - Dent - Small / (L) Front Door, Molding - Scratch & Dent - Medium / (R) Rear Fender, Molding - Scratch & Dent - Large / (R) Rear Door, Molding - Scratch & Dent - Small / Bonnet, Headlight - Dent - Small / Rear Bumper, Lamps, Panels - Scratch - Medium / (L) Rear Door, Molding - Scratch - Small / (R) Front Fender, Molding - Scratch - Minimal / Front Bumper, Grille, Lamps - Scratch - Medium |
