## General Information

| Make | Toyota | Model | Innova |
| YOM | 2022 | Odo Meter Reading | 84,470 |
| Registration No. | EAF4812 | Chassis No. | PA2JA8EMXN0114137 |

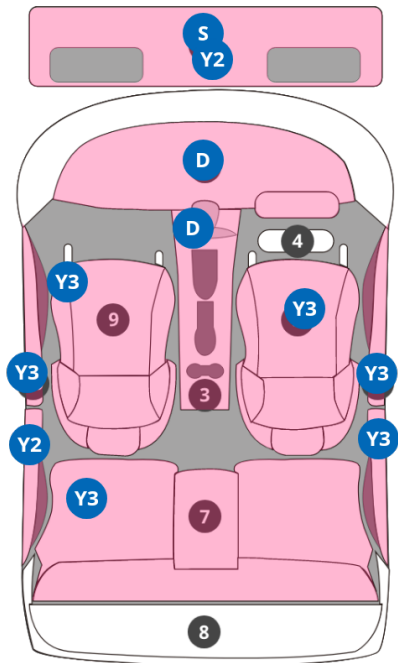
| Interior Evaluation : <span style="color: red;">D</span> | Exterior Evaluation : <span style="color: red;">E</span> |
| <p><b>Remarks</b></p> <p>Overall Interior - Smell - Yes / (R) Front Seat - Grime - Medium / (R) Front Trim - Grime - Medium / (R) Rear Trim - Grime - Medium / Ceiling - Grime - Small / Rear Seat - Grime - Medium / (L) Rear Trim - Grime - Small / (L) Front Trim - Grime - Medium / (L) Front Seat - Grime - Medium / Console, Switchs, Vents - Traces of Adhesive Tape - Yes / Dashboard - Traces of Adhesive Tape - Yes</p> | <p><b>Remarks</b></p> <p>(L) Front Door, Molding - Repair mark - Yes / (L) Front Door, Molding - Scratch &amp; Dent - Medium / (L) Rear Door, Molding - Scratch &amp; Dent - Medium / Front Bumper, Grille, Lamps - Scratch &amp; Dent - Large / (R) Front Door, Molding - Repair mark - Yes / (R) Front Door, Molding - Scratch &amp; Dent - Medium / (R) Rear Fender, Molding - Scratch &amp; Dent - Medium / (R) Rear Fender, Molding - Repair mark - Yes / Rear Bumper, Lamps, Panels - Repair mark - Yes / Rear Bumper, Lamps, Panels - Scratch &amp; Dent - Medium / Trunk Hood, Rear Gate - Dent - Small / (R) Front Fender, Molding - Scratch - Small / (L) Mirror - Crack - Damaged / Roof - Dent - Medium / (R) Rear Door, Molding - Scratch - Small</p> |
