## General Information

| Make | Toyota | Model | Vios |
| YOM | 2024 | Mileage | 4,787 |
| Registration No. | DBN7083 | Chassis No. | PA1B18F30P4234281 |

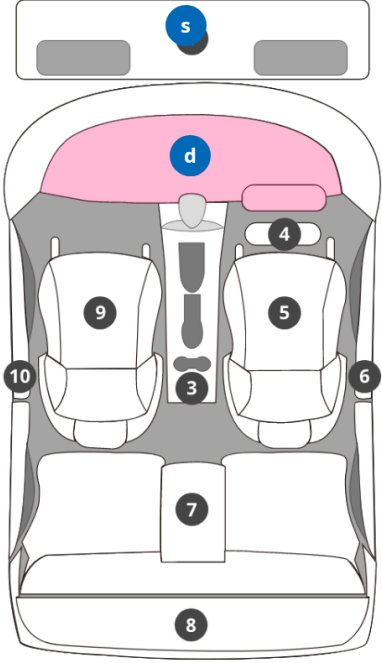
| Interior Evaluation : <b>B</b> | Exterior Evaluation : <b>A</b> |
| <p><b>Remarks</b><br/>Dashboard - Traces of Adhesive Tape - Yes / Overall Interior - Smell - Yes</p> | <p><b>Remarks</b><br/>(L) Front Door, Molding - Scratch - Minimal / Rear Bumper, Lamps, Panels - Scratch - Small / (R) Front Fender, Molding - Scratch - Minimal</p> |

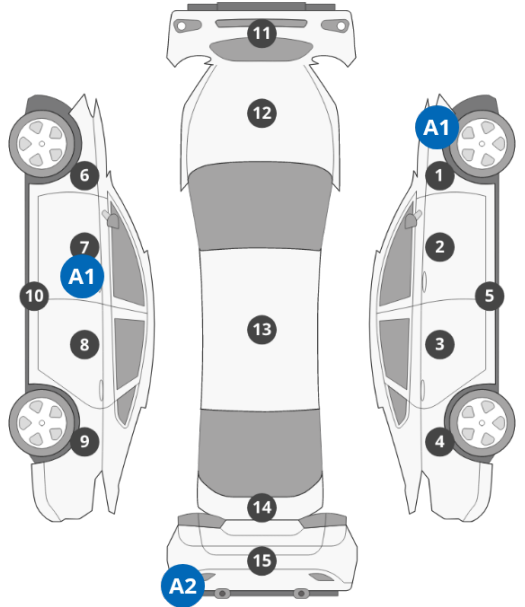
| Inspector Notes |
|---|
| swirl marks and hairline scratches around the exterior. |
