General Information

Make	Toyota	Model	Vios
YOM	2024	Odo Meter Reading	30,903
Registration No.	NHR1240	Chassis No.	PA1B18F37P4226646
CC	1.3	Transmission	CVT
Fuel Type	Gas	Type of Body	Sedan
Colour	Black

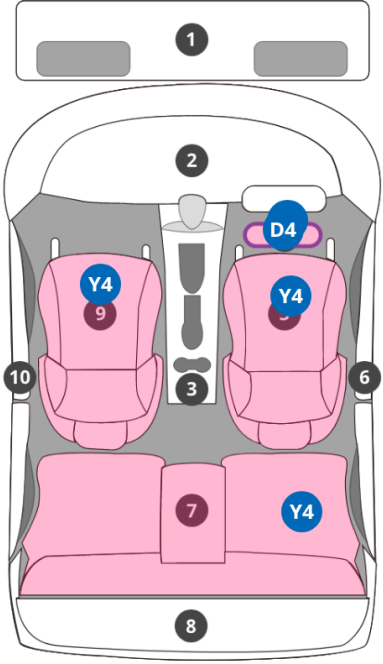
Interior Evaluation : C	Exterior Evaluation : D

<p>a : Cut, Fray d : Loose, Deformed k : Animal Hair s : Smell t : Cigarette Burns x : Defective y : Stain</p>

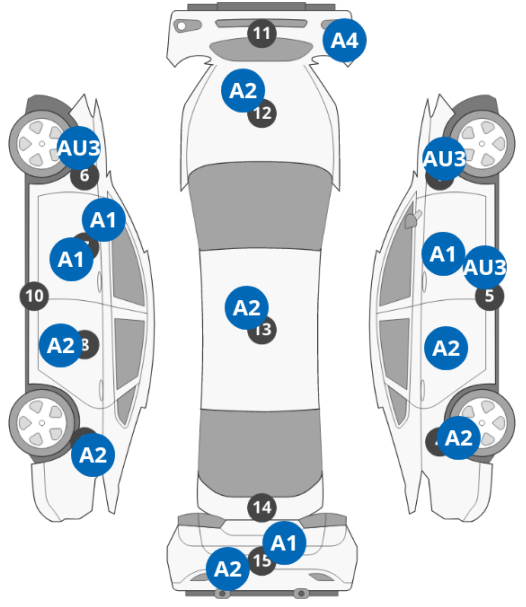
<p>A : Scratch AU : Scratch & Dent B : Modified C : Corrosion G : Stone chip P : Faded S : Rust SC : Rust & Corrosion U : Dent X : Defective Y : Crack, Gap</p>
<p>Remarks (R) Front Seat - Grime - Large / (L) Front Seat - Grime - Large / Overall Interior - Worn as per age - Yes / Rear Seat - Grime - Large / Mat Other - Missing - Yes / (L) Front Floor Mat - Worked - Large</p>	<p>Remarks (L) Front Door, Molding - Scratch - Minimal / (L) Rear Door, Molding - Scratch - Small / (L) Front Fender, Molding - Scratch & Dent - Medium / Front Bumper, Grille, Lamps - Scratch - Large / (R) Front Fender, Molding - Scratch & Dent - Medium / (R) Step, In-panel, Side Spoiler - Scratch & Dent - Medium / (R) Front Door, Molding - Scratch - Minimal / (R) Rear Door, Molding - Scratch - Small / Rear Bumper, Lamps, Panels - Scratch - Small / Trunk Hood, Rear Gate - Scratch - Minimal / (L) Rear Fender, Molding - Scratch - Small / Roof - Scratch - Small / Bonnet, Headlight - Scratch - Small / (L) Mirror - Scratch, Peeled - Minimal / (R) Rear Fender, Molding - Scratch - Small</p>

<p>Inspector Notes</p>
<p>with LTO plate and Jack, Sparetire and incomplete tools. no warranty booklet. scratch and crack tail light and headlight light.</p>
