## General Information

| Make | Ford | Model | Everest |
| Registration No. | ABO3858 | Chassis No. | MNCUS4D10EW509053 |

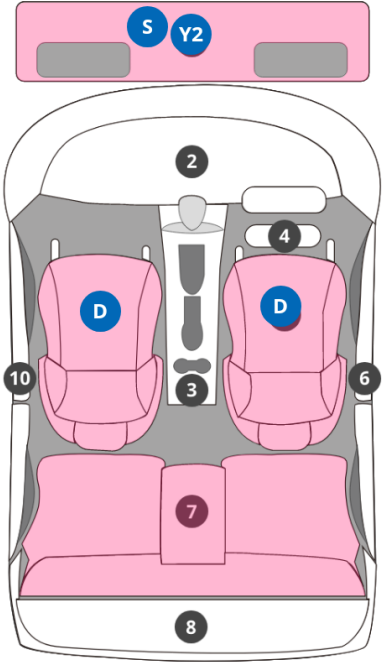
| Interior Evaluation : <span style="color: red;">C</span> | Exterior Evaluation : <span style="color: red;">D</span> |
| <b>Remarks</b><br>Overall Interior - Worn as per age - Yes / (R) Front Seat - Worn - Yes / Ceiling - Grime - Small / Rear Seat - Worn - Yes / (L) Front Seat - Worn - Yes / Overall Interior - Smell - Yes | <b>Remarks</b><br>(L) Rear Fender - Repair Traces - Yes / Front Bumper, Grille, Lamps - Scratch & Dent - Medium / (R) Front Fender, Molding - Scratch & Dent - Medium / Bonnet, Headlight - Scratch & Dent - Small / (L) Rear Door, Molding - Scratch & Dent - Medium / (L) Mirror - Scratch - Small / (R) Front Door, Molding - Scratch & Dent - Medium / Rear Bumper, Lamps, Panels - Scratch & Dent - Large / (R) Rear Fender, Molding - Repair mark - Yes / (R) Rear Door, Molding - Scratch - Small / Roof - Scratch & Dent - Medium |
