## General Information

| Make | Toyota | Model | Avanza |
| Registration No. | NHM7337 | Chassis No. | MHFAA1BY5R0022684 |

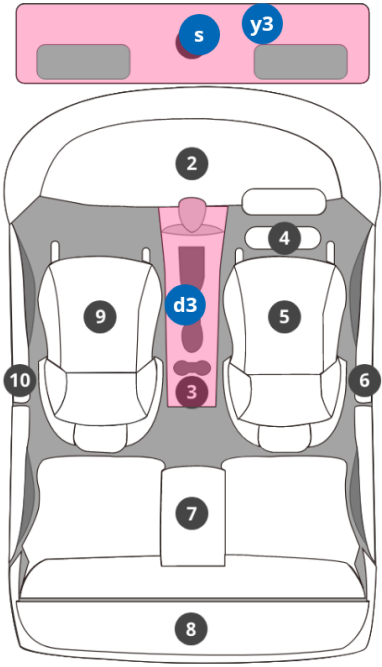
| <b>Interior Evaluation :</b> <b>B</b> | <b>Exterior Evaluation :</b> <b>D</b> |
| <b>Remarks</b><br>Console, Switchs, Vents - Loose, Deformed, Grime - Medium / Overall Interior - Smell - Yes / Ceiling - Grime - Medium | <b>Remarks</b><br>(L) Front Fender, Molding - Dent - Minimal / (L) Mirror - Scratch - Small / (L) Front Door, Molding - Scratch - Small / (L) Rear Door, Molding - Scratch - Small / (R) Front Fender, Molding - Scratch & Dent - Minimal / (R) Step, In-panel, Side Spoiler - Scratch & Dent - Medium / (R) Mirror - Scratch - Small / (R) Front Door, Molding - Scratch - Medium / Front Bumper, Grille, Lamps - Scratch & Dent - Large / (R) Rear Door, Molding - Scratch - Medium / Rear Bumper, Lamps, Panels - Scratch - Medium / (R) Rear Fender, Molding - Scratch & Dent - Small |

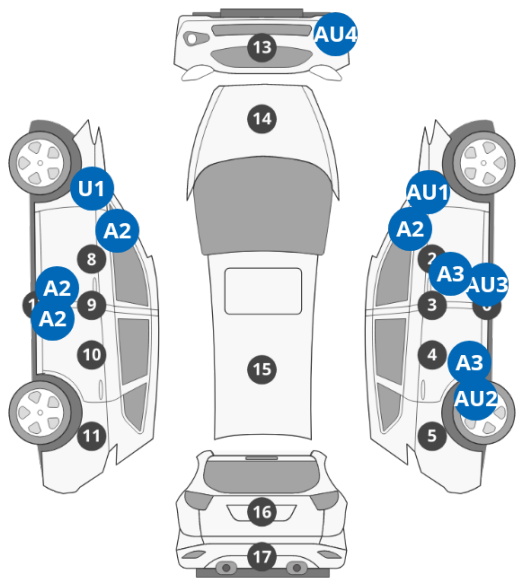
more scratch and dents at the exterior. swirl marks and hairline scratches around the exterior. mattings has dirty marks.
