General Information

Make	Toyota	Model	Rush
YOM	2021	Odo Meter Reading	77,002
Registration No.	DAT6565	Chassis No.	MHKE8FF3PLK027697
CC	1.5	Transmission	A/T
Fuel Type	Gas	Type of Body	SUV
Colour	Red

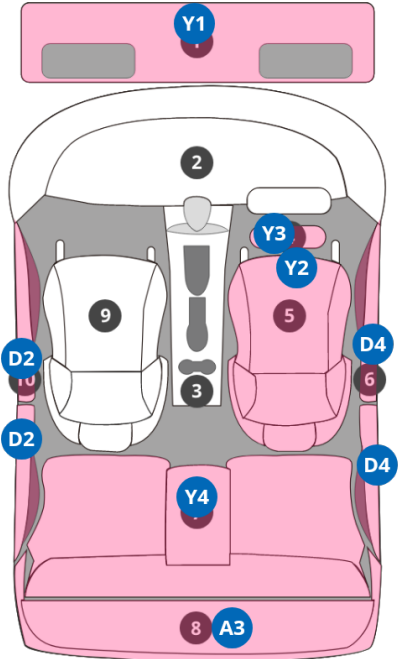
Interior Evaluation : D	Exterior Evaluation : C

<p>a : Cut, Fray d : Loose, Deformed k : Animal Hair s : Smell t : Cigarette Burns x : Defective y : Stain</p>

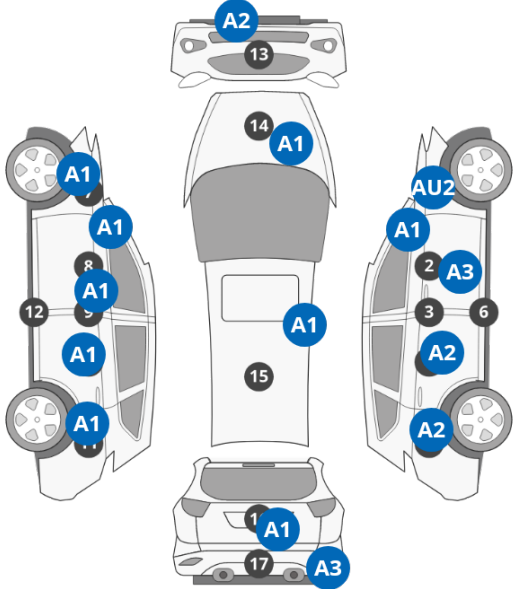
<p>A : Scratch AU : Scratch & Dent B : Modified C : Corrosion G : Stone chip P : Faded S : Rust SC : Rust & Corrosion U : Dent X : Defective Y : Crack, Gap</p>
<p>Remarks Rear Seat - Grime - Large / Mat Other - Grime - Medium / (R) Rear Trim - Worked - Large / (R) Front Seat - Grime - Small / (R) Front Trim - Worked - Large / Trunk Room - Worn, Scratch, Cut, Crack - Medium / (L) Rear Trim - Worked - Small / (L) Front Trim - Worked - Small / Ceiling - Grime - Minimal</p>	<p>Remarks (R) Front Fender, Molding - Scratch & Dent - Small / (R) Mirror - Scratch - Minimal / (R) Front Door, Molding - Scratch - Medium / (R) Rear Door, Molding - Scratch - Small / (R) Rear Fender, Molding - Scratch - Small / Rear Bumper, Lamps, Panels - Scratch - Medium / Trunk Hood, Rear Gate - Scratch - Minimal / Roof - Scratch - Minimal / (L) Rear Fender, Molding - Scratch - Minimal / (L) Rear Door, Molding - Scratch - Minimal / (L) Front Door, Molding - Scratch - Minimal / (L) Mirror - Scratch - Minimal / (L) Front Fender, Molding - Scratch - Minimal / Front Bumper, Grille, Lamps - Scratch - Small / Bonnet, Headlight - Scratch - Minimal</p>
