General Information

Make	Toyota	Model	Vios
YOM	2022	Odo Meter Reading	89,603
Registration No.	NFL2652	Chassis No.	PA1B18F36N4176299
CC	1.3	Transmission	CVT
Fuel Type	Gas	Type of Body	Sedan
Colour	Red Mica Metallic

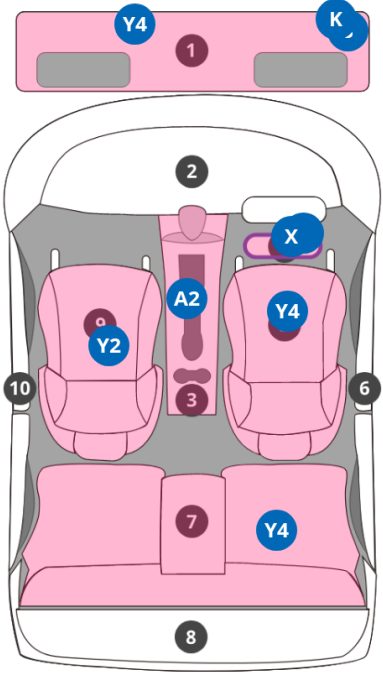
Interior Evaluation : C	Exterior Evaluation : C

<p>a : Cut, Fray d : Loose, Deformed k : Animal Hair s : Smell t : Cigarette Burns x : Defective y : Stain</p>

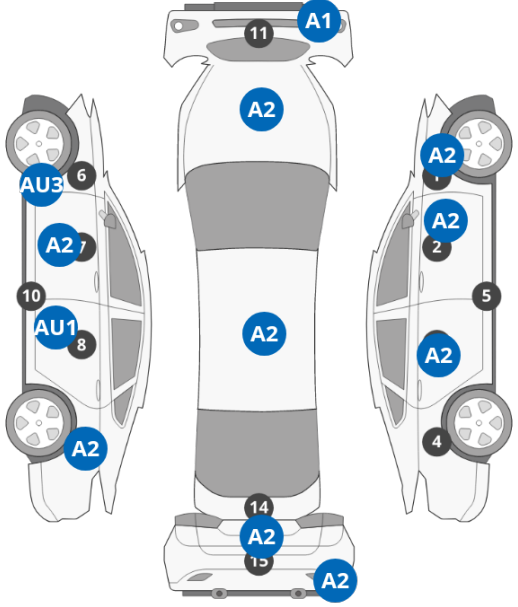
<p>A : Scratch AU : Scratch & Dent B : Modified C : Corrosion G : Stone chip P : Faded S : Rust SC : Rust & Corrosion U : Dent X : Defective Y : Crack, Gap</p>
<p>Remarks Overall Interior - Worn as per age - Yes / Overall Interior - Smell - Yes / Overall Interior - Animal Hair - Yes / (R) Front Floor Mat - Missing - Yes / (L) Front Floor Mat - Missing - Yes / (R) Front Seat - Grime - Large / Rear Seat - Grime - Large / Ceiling - Grime - Large / (L) Front Seat - Grime - Small / Knobs - Worn, Peel, Crack - Small</p>	<p>Remarks (L) Rear Fender, Molding - Scratch - Small / (L) Rear Door, Molding - Scratch & Dent - Minimal / (L) Front Door, Molding - Scratch - Small / (L) Front Fender, Molding - Scratch & Dent - Medium / Bonnet, Headlight - Scratch - Small / Front Bumper, Grille, Lamps - Scratch - Minimal / Roof - Scratch - Small / Rear Bumper, Lamps, Panels - Scratch - Small / (R) Front Door, Molding - Scratch - Small / (R) Rear Door, Molding - Scratch - Small / (R) Front Fender, Molding - Scratch - Small / Trunk Hood, Rear Gate - Scratch - Small</p>
