## General Information

| Make | Toyota | Model | Wigo |

## Body / Panel Condition

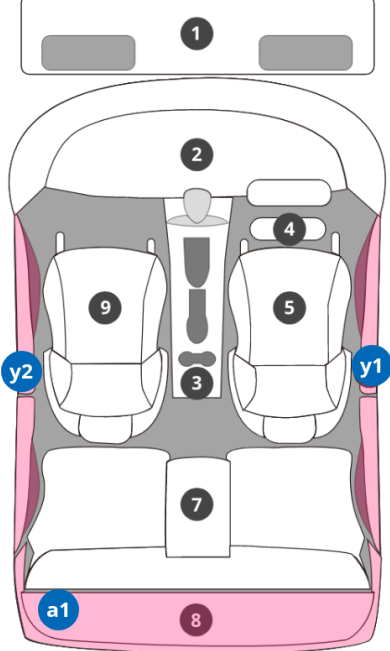
| Interior Evaluation : <span style="color: red;">A</span> | Exterior Evaluation : <span style="color: red;">B</span> |
| <b>Remarks</b><br>Trunk Room - Worn, Scratch, Cut, Crack - Minimal | <b>Remarks</b><br>Front Bumper, Grille, Lamps - Scratch - Medium / (L) Front Door, Molding - Scratch & Dent - Minimal / (L) Step, In-panel, Side Spoiler - Scratch - Minimal / (L) Rear Fender, Molding - Scratch - Small / (L) Rear Door, Molding - Scratch - Small / Trunk Hood, Rear Gate - Scratch - Small / (R) Rear Fender, Molding - Scratch - Small / (R) Rear Door, Molding - Scratch - Minimal / (R) Step, In-panel, Side Spoiler - Scratch - Minimal / (R) Front Door, Molding - Scratch - Minimal / (R) Front Fender, Molding - Scratch - Small |

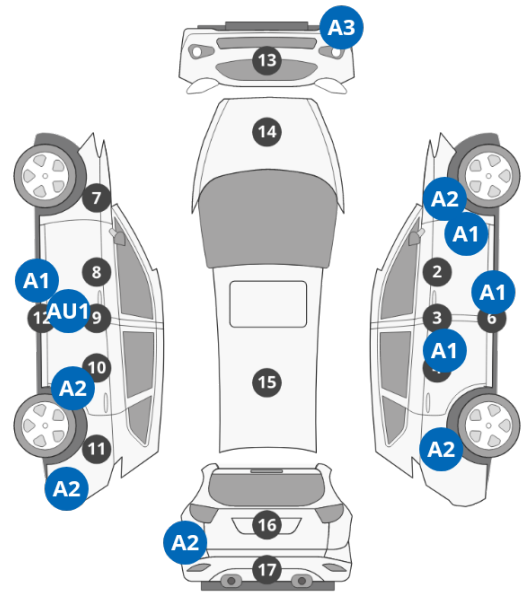
| Inspector Notes |
|---|
| no retractable mirror featured in this unit. , more light scratches around the exterior. adhesive marks at both side mirrors. |
