## General Information

| Make | Ford | Model | Fiesta |

## Body / Panel Condition

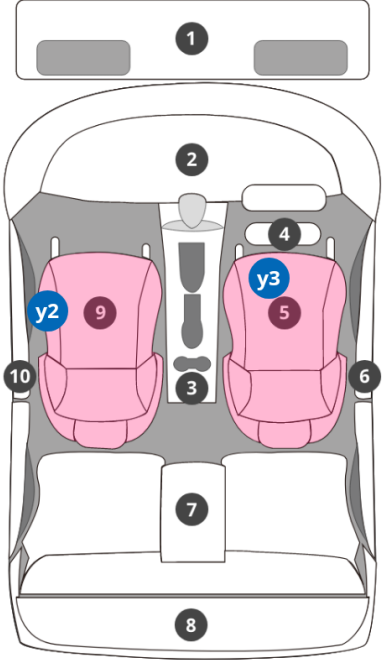
| <b>Interior Evaluation :</b> <span style="color: red; font-weight: bold;">B</span> | <b>Exterior Evaluation :</b> <span style="color: red; font-weight: bold;">C</span> |
| <b>Remarks</b><br>(L) Front Seat - Grime - Small / (R) Front Seat - Grime - Medium / (L) Front Seat Knobs - Stuck - Yes / Overall Interior - Worn as per age - Yes | <b>Remarks</b><br>(R) Front Door - Repair Traces - Yes / (R) Step - Repair Traces - Yes / (R) Front Fender - Repair Traces - Yes / Bonnet - Repair Traces - Yes / (L) Front Fender - Repair Traces - Yes / (L) Front Door - Repair Traces - Yes / (L) Step - Repair Traces - Yes / (R) Rear Fender - Repair Traces - Yes / (R) Rear Door - Repair Traces - Yes / Bonnet, Headlight - Dent - Small / Rear Bumper, Lamps, Panels - Scratch - Large / Overall Exterior - Faded(Color, Gloss) - Yes / (L) Mirror - Scratch, Peeled - Minimal / (R) Front Door, Molding - Scratch - Minimal / (R) Rear Fender, Molding - Repair mark - Difference in Color |
