General Information

Make	Toyota	Model	Vios
YOM	2021	Odo Meter Reading	39,363
Registration No.	BAE8938	Chassis No.	PA1B18F35M4154728
CC	1.3	Transmission	CVT
Fuel Type	Gas	Type of Body	Sedan
Colour	Green

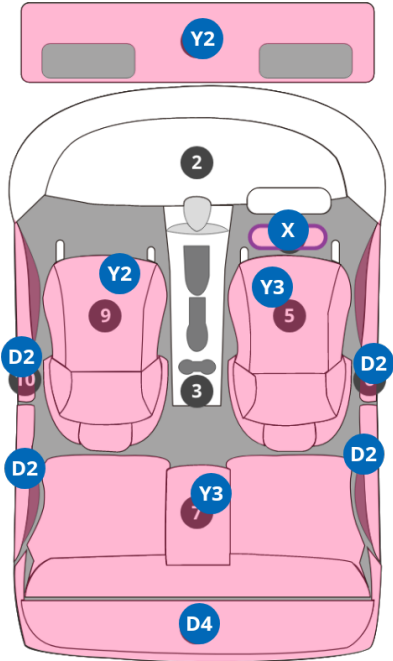
Interior Evaluation : C	Exterior Evaluation : E

<p>a : Cut, Fray d : Loose, Deformed k : Animal Hair s : Smell t : Cigarette Burns x : Defective y : Stain</p>

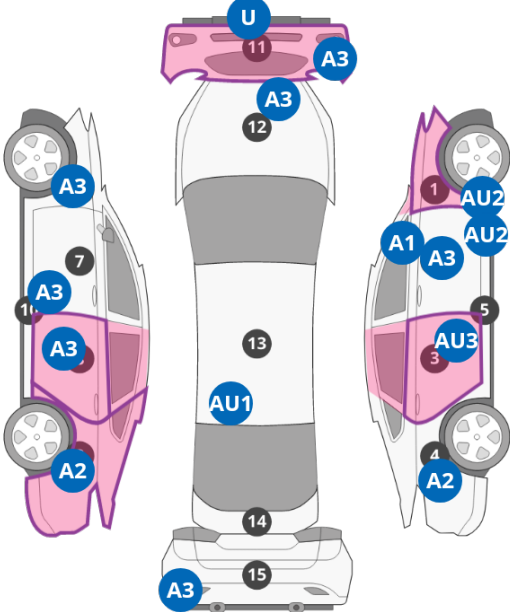
<p>A : Scratch AU : Scratch & Dent B : Modified C : Corrosion G : Stone chip P : Faded S : Rust SC : Rust & Corrosion U : Dent X : Defective Y : Crack, Gap</p>
<p>Remarks Trunk Room - Worked - Large / Mat Other - Missing - Yes / (R) Front Seat - Grime - Medium / (R) Front Trim - Worked - Small / (L) Front Seat - Grime - Small / (L) Front Trim - Worked - Small / Rear Seat - Grime - Medium / Ceiling - Grime - Small / (L) Rear Trim - Worked - Small / (R) Rear Trim - Worked - Small</p>	<p>Remarks (R) Front Fender - Repair Traces - Yes / (L) Rear Door - Repair Traces - Yes / (L) Rear Fender - Repair Traces - Yes / (R) Rear Door - Repair Traces - Yes / (R) Front Fender, Molding - Repair mark - Yes / (R) Rear Door, Molding - Repair mark - Yes / (L) Rear Fender, Molding - Repair mark - Yes / (L) Rear Door, Molding - Repair mark - Yes / Front Bumper, Grille, Lamps - Repair mark - Yes / Member (Bolted) - Dent - Yes / (R) Rear Door, Molding - Scratch & Dent - Medium / (R) Front Fender, Molding - Scratch & Dent - Small / (R) Step, In-panel, Side Spoiler - Scratch & Dent - Small / (R) Front Door, Molding - Scratch - Medium / (R) Rear Fender, Molding - Scratch - Small / Roof - Scratch & Dent - Minimal / Rear Bumper, Lamps, Panels - Scratch - Medium / (L) Rear Fender, Molding - Scratch - Small / (L) Rear Door, Molding - Scratch - Medium / (L) Front Door, Molding - Scratch - Medium / (L) Front Fender, Molding - Scratch - Medium / Front Bumper, Grille, Lamps - Scratch - Medium / Bonnet, Headlight - Scratch - Medium / (R) Mirror - Scratch - Minimal</p>
