General Information

Make	Toyota	Model	Vios
YOM	2023	Odo Meter Reading	26,694
Registration No.	DBB5967-1	Chassis No.	PA1B18F35P4205746
CC	1.3	Transmission	CVT
Fuel Type	Gas	Type of Body	Sedan
Colour	Red

Body / Panel Condition

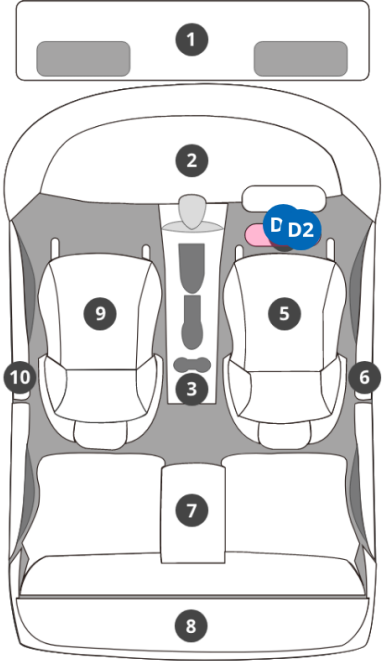
Interior Evaluation : C	Exterior Evaluation : C

<p>a : Cut, Fray d : Loose, Deformed k : Animal Hair s : Smell t : Cigarette Burns x : Defective y : Stain</p>

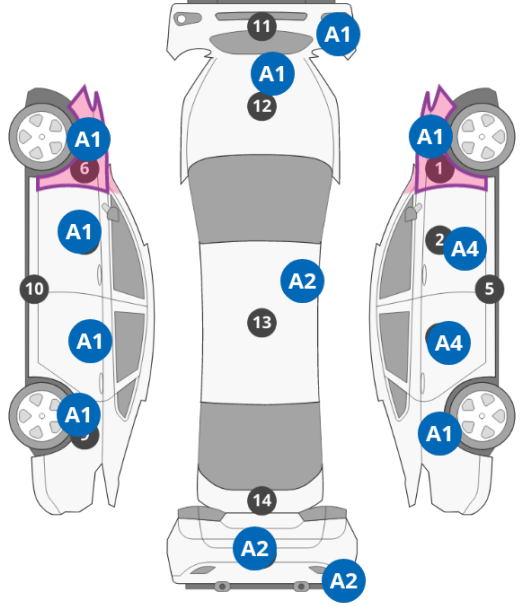
<p>A : Scratch AU : Scratch & Dent B : Modified C : Corrosion G : Stone chip P : Faded S : Rust SC : Rust & Corrosion U : Dent X : Defective Y : Crack, Gap</p>
<p>Remarks Overall Interior - Worn as per age - Yes / (L) Front Floor Mat - Worked - Small / Mat Other - Crinkle - Small</p>	<p>Remarks (R) Front Fender - Repair Traces - Yes / (L) Front Fender - Repair Traces - Yes / (L) Front Fender, Molding - Repair mark - Yes / (R) Front Fender, Molding - Repair mark - Yes / (L) Rear Fender, Molding - Scratch - Minimal / Trunk Hood, Rear Gate - Scratch - Small / Rear Bumper, Lamps, Panels - Scratch - Small / (R) Rear Door, Molding - Scratch - Large / (R) Front Door, Molding - Scratch - Large / (R) Rear Fender, Molding - Scratch - Minimal / Roof - Scratch - Small / Bonnet, Headlight - Scratch - Minimal / Front Bumper, Grille, Lamps - Scratch - Minimal / (R) Front Fender, Molding - Scratch - Minimal / (L) Front Fender, Molding - Scratch - Minimal / (L) Front Door, Molding - Scratch - Minimal / (L) Rear Door, Molding - Scratch - Minimal</p>
