## General Information

| <b>Make</b> | Toyota | <b>Model</b> | Vios |
| <b>Registration No.</b> | NKK2820 | <b>Chassis No.</b> | PA1B18F36R4270947 |

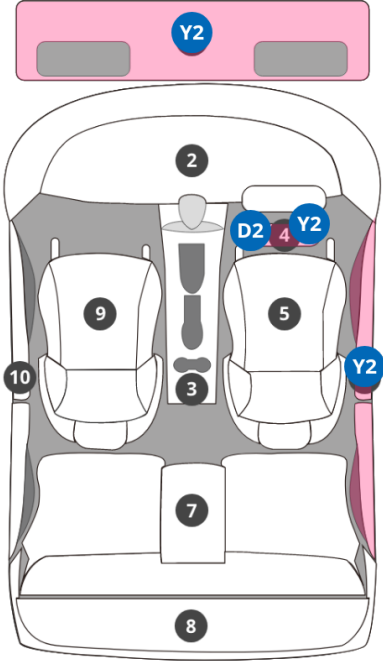
| <b>Interior Evaluation :</b> <span style="float: right; color: red; font-weight: bold;">A</span> | <b>Exterior Evaluation :</b> <span style="float: right; color: red; font-weight: bold;">D</span> |

| <p><b>Remarks</b><br/>(R) Front Trim - Grime - Small / (R) Front Floor Mat - Grime - Small / Ceiling - Grime - Small / (L) Front Floor Mat - Worked - Small</p> | <p><b>Remarks</b><br/>(L) Rear Fender, Molding - Scratch &amp; Dent - Medium / Trunk Hood, Rear Gate - Scratch - Large / (L) Rear Door, Molding - Scratch - Small / (R) Rear Fender, Molding - Scratch &amp; Dent - Small / (R) Rear Door, Molding - Scratch &amp; Dent - Medium / (R) Front Door, Molding - Scratch - Small / Rear Bumper, Lamps, Panels - Scratch - Medium / Front Bumper, Grille, Lamps - Scratch - Medium / Bonnet, Headlight - Scratch - Minimal / (L) Front Door, Molding - Scratch - Minimal / (L) Front Fender, Molding - Scratch - Small / (R) Front Fender, Molding - Scratch - Small</p> |
