General Information

Make	Toyota	Model	Vios
YOM	2022	Odo Meter Reading	62,319
Registration No.	NFP5918	Chassis No.	PA1B18F34N4191612
CC	1.3	Transmission	CVT
Fuel Type	Gas	Type of Body	Sedan
Colour	Red Mica Metallic

Body / Panel Condition

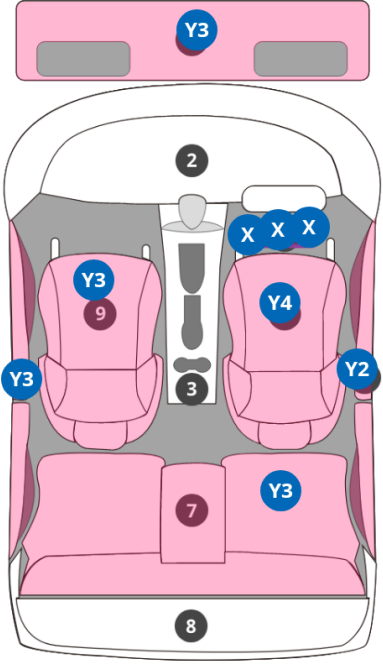
Interior Evaluation : C	Exterior Evaluation : E

<p>a : Cut, Fray d : Loose, Deformed k : Animal Hair s : Smell t : Cigarette Burns x : Defective y : Stain</p>

<p>A : Scratch AU : Scratch & Dent B : Modified C : Corrosion G : Stone chip P : Faded S : Rust SC : Rust & Corrosion U : Dent X : Defective Y : Crack, Gap</p>
<p>Remarks Ceiling - Grime - Medium / (R) Front Trim - Grime - Small / (R) Front Seat - Grime - Large / (R) Front Floor Mat - Missing - Yes / Mat Other - Missing - Yes / (L) Front Floor Mat - Missing - Yes / Rear Seat - Grime - Medium / (L) Front Seat - Grime - Medium / (L) Front Trim - Grime - Medium</p>	<p>Remarks (L) Front Fender, Molding - Scratch & Dent - Large / (L) Front Door, Molding - Scratch & Dent - Small / (L) Rear Door, Molding - Scratch & Dent - Large / Front Bumper, Grille, Lamps - Scratch & Dent - Large / (R) Mirror - Scratch - Minimal / (L) Rear Fender, Molding - Scratch & Dent - Large / Rear Bumper, Lamps, Panels - Scratch & Dent - Large / Trunk Hood, Rear Gate - Scratch & Dent - Small / (R) Rear Fender, Molding - Scratch & Dent - Large / (R) Rear Door, Molding - Scratch & Dent - Large / (R) Front Door, Molding - Scratch & Dent - Medium</p>
