General Information

Make	Toyota	Model	Vios
YOM	2022	Odo Meter Reading	11,926
Registration No.	BAC8395	Chassis No.	PA1B18F31N4181233
CC	1.3	Transmission	CVT
Fuel Type	Gas	Type of Body	Sedan
Colour	Red Mica Metallic

Body / Panel Condition

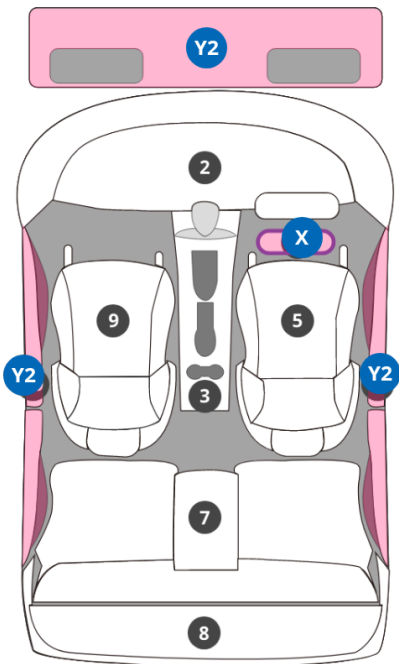
Interior Evaluation : B	Exterior Evaluation : E

<p>a : Cut, Fray d : Loose, Deformed k : Animal Hair s : Smell t : Cigarette Burns x : Defective y : Stain</p>

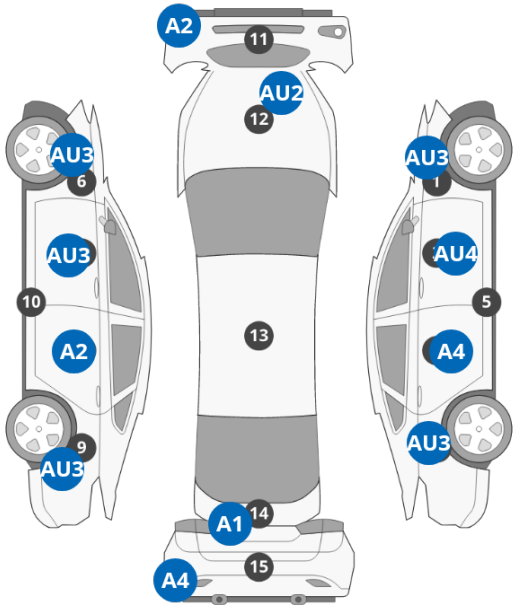
<p>A : Scratch AU : Scratch & Dent B : Modified C : Corrosion G : Stone chip P : Faded S : Rust SC : Rust & Corrosion U : Dent X : Defective Y : Crack, Gap</p>
<p>Remarks Mat Other - Missing - Yes / (R) Front Trim - Grime - Small / (L) Front Trim - Grime - Small / Ceiling - Grime - Small</p>	<p>Remarks (R) Front Fender, Molding - Scratch & Dent - Medium / (R) Front Door, Molding - Scratch & Dent - Large / (R) Rear Door, Molding - Scratch - Large / (R) Rear Fender, Molding - Scratch & Dent - Medium / Rear Bumper, Lamps, Panels - Scratch - Large / (L) Rear Fender, Molding - Scratch & Dent - Medium / (L) Rear Door, Molding - Scratch - Small / (L) Front Door, Molding - Scratch & Dent - Medium / (L) Front Fender, Molding - Scratch & Dent - Medium / Bonnet, Headlight - Scratch & Dent - Small / Front Bumper, Grille, Lamps - Scratch - Small / Trunk Hood, Rear Gate - Scratch - Minimal</p>
