General Information

Make	Toyota	Model	Vios
YOM	2022	Odo Meter Reading	111,661
Registration No.	NES8218	Chassis No.	PA1B18F32M4165511
CC	1.3	Transmission	CVT
Fuel Type	Gas	Type of Body	Sedan
Colour	Blue

Body / Panel Condition

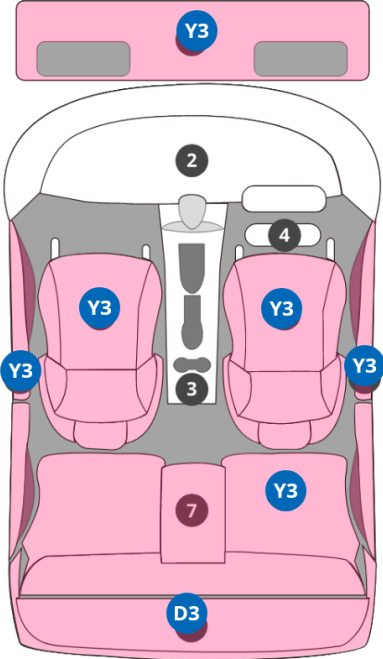
Interior Evaluation : C	Exterior Evaluation : E

<p>a : Cut, Fray d : Loose, Deformed k : Animal Hair s : Smell t : Cigarette Burns x : Defective y : Stain</p>

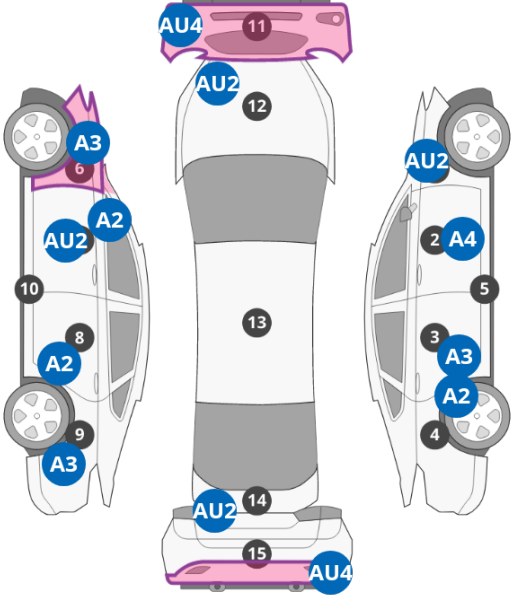
<p>A : Scratch AU : Scratch & Dent B : Modified C : Corrosion G : Stone chip P : Faded S : Rust SC : Rust & Corrosion U : Dent X : Defective Y : Crack, Gap</p>
<p>Remarks (R) Front Trim - Grime - Medium / (R) Front Seat - Grime - Medium / Rear Seat - Grime - Medium / Trunk Room - Loose, Deformed - Medium / (L) Front Trim - Grime - Medium / (L) Front Seat - Grime - Medium / Ceiling - Grime - Medium</p>	<p>Remarks (L) Front Fender - Repair Traces - Yes / (L) Rear Door - Repair Traces - Yes / (L) Front Fender, Molding - Repair mark - Yes / Front Bumper, Grille, Lamps - Repair mark - Yes / Rear Bumper, Lamps, Panels - Repair mark - Yes / Front Bumper, Grille, Lamps - Scratch & Dent - Large / Bonnet, Headlight - Scratch & Dent - Small / (R) Front Fender, Molding - Scratch & Dent - Small / (R) Front Door, Molding - Scratch - Large / (R) Rear Door, Molding - Scratch - Medium / (R) Rear Fender, Molding - Scratch - Small / Rear Bumper, Lamps, Panels - Scratch & Dent - Large / Trunk Hood, Rear Gate - Scratch & Dent - Small / (L) Rear Fender, Molding - Scratch - Medium / (L) Rear Door, Molding - Scratch - Small / (L) Mirror - Scratch - Small / (L) Front Door, Molding - Scratch & Dent - Small / (L) Front Fender, Molding - Scratch - Medium</p>
