General Information

Make	Toyota	Model	Vios
YOM	2024	Odo Meter Reading	3,421
Registration No.	CCC6192	Chassis No.	PA1B18F31R4242117
CC	1.3	Transmission	CVT
Fuel Type	Gas	Type of Body	Sedan
Colour	Black

Body / Panel Condition

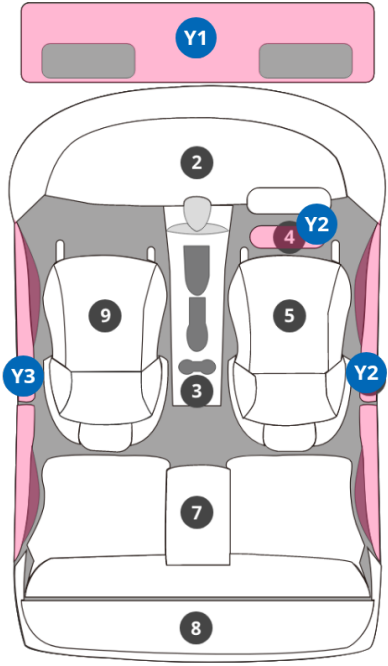
<p>a : Cut, Fray d : Loose, Deformed k : Animal Hair s : Smell t : Cigarette Burns x : Defective y : Stain</p>

<p>A : Scratch AU : Scratch & Dent B : Modified C : Corrosion G : Stone chip P : Faded S : Rust SC : Rust & Corrosion U : Dent X : Defective Y : Crack, Gap</p>
<p>Remarks (R) Front Trim - Grime - Small / (R) Front Floor Mat - Grime - Small / Ceiling - Grime - Minimal / (L) Front Trim - Grime - Medium</p>	<p>Remarks (L) Mirror - Scratch - Minimal / (L) Front Door, Molding - Scratch - Medium / (L) Rear Door, Molding - Scratch - Medium / (R) Front Door, Molding - Scratch - Large / (R) Rear Fender, Molding - Scratch - Medium / (R) Front Fender, Molding - Scratch - Small / Rear Bumper, Lamps, Panels - Scratch - Small / Trunk Hood, Rear Gate - Scratch - Medium / (L) Front Fender, Molding - Scratch - Small / Front Bumper, Grille, Lamps - Scratch - Medium / (R) Rear Door, Molding - Scratch - Medium</p>
