General Information

Make	Toyota	Model	Hiace
YOM	2022	Odo Meter Reading	64,282
Registration No.	NIE2607	Chassis No.	JTFJT02P5N5031672
CC	3.0	Transmission	M/T
Fuel Type	Diesel	Type of Body	Van
Colour	Silver

Body / Panel Condition

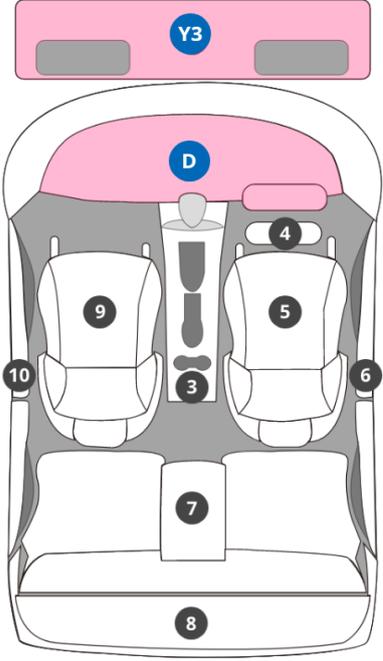
Interior Evaluation : B	Exterior Evaluation : C

<p>a : Cut, Fray d : Loose, Deformed k : Animal Hair s : Smell t : Cigarette Burns x : Defective y : Stain</p>

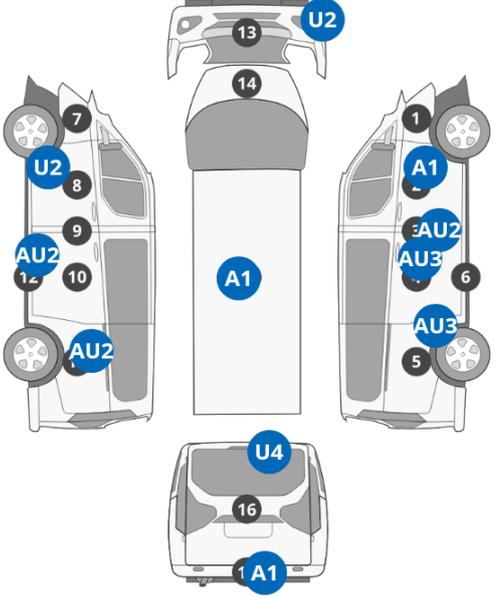
<p>A : Scratch AU : Scratch & Dent B : Modified C : Corrosion G : Stone chip P : Faded S : Rust SC : Rust & Corrosion U : Dent X : Defective Y : Crack, Gap</p>
<p>Remarks Ceiling - Grime - Medium / Dashboard - Traces of Adhesive Tape - Yes</p>	<p>Remarks (R) Front Door, Molding - Scratch - Minimal / (R) Center Panel - Scratch & Dent - Small / (R) Rear Door, Molding - Scratch & Dent - Medium / (R) Rear Fender, Molding - Scratch & Dent - Medium / Trunk Hood, Rear Gate - Dent - Large / Rear Bumper, Lamps, Panels - Scratch - Minimal / (L) Rear Door, Molding - Scratch & Dent - Small / (L) Front Door, Molding - Dent - Small / Front Bumper, Grille, Lamps - Dent - Small / Roof - Scratch - Minimal / (L) Rear Fender, Molding - Scratch & Dent - Small</p>
