General Information

Make	Toyota	Model	Vios
YOM	2023	Odo Meter Reading	27,007
Registration No.	DBG5250	Chassis No.	PA1B18F38R4200492
CC	1.3	Transmission	CVT
Fuel Type	Gas	Type of Body	Sedan
Colour	Red

Body / Panel Condition

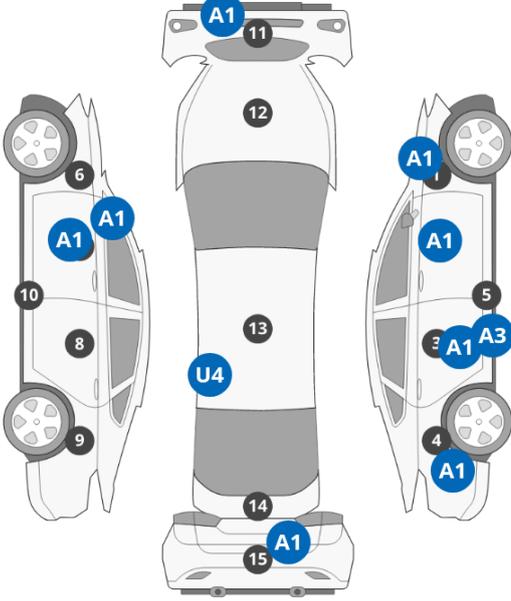
Interior Evaluation :	C	Exterior Evaluation :	C

<p>a : Cut, Fray d : Loose, Deformed k : Animal Hair s : Smell t : Cigarette Burns x : Defective y : Stain</p>		<p>A : Scratch AU : Scratch & Dent B : Modified C : Corrosion G : Stone chip P : Faded S : Rust SC : Rust & Corrosion U : Dent X : Defective Y : Crack, Gap</p>	
<p>Remarks (R) Front Seat - Grime - Small / (R) Front Trim - Grime - Minimal / Rear Seat - Grime - Large / (L) Front Trim - Grime - Small / (L) Front Seat - Grime - Medium / (R) Front Floor Mat - Missing - Yes / (L) Front Floor Mat - Missing - Yes / Mat Other - Missing - Yes / Ceiling - Grime - Minimal</p>		<p>Remarks (R) Rear Fender, Molding - Scratch - Minimal / Trunk Hood, Rear Gate - Scratch - Minimal / (R) Rear Door, Molding - Scratch - Minimal / (R) Step, In-panel, Side Spoiler - Scratch - Medium / (R) Front Door, Molding - Scratch - Minimal / (R) Front Fender, Molding - Scratch - Minimal / Front Bumper, Grille, Lamps - Scratch - Minimal / (L) Mirror - Scratch - Minimal / (L) Front Door, Molding - Scratch - Minimal / Roof - Dent - Large</p>
