## General Information

| Make | Toyota | Model | Raize |
| YOM | 2024 | Odo Meter Reading | 33,335 |
| Registration No. | NHQ8316 | Chassis No. | MHKAA1BA5PJ109027 |

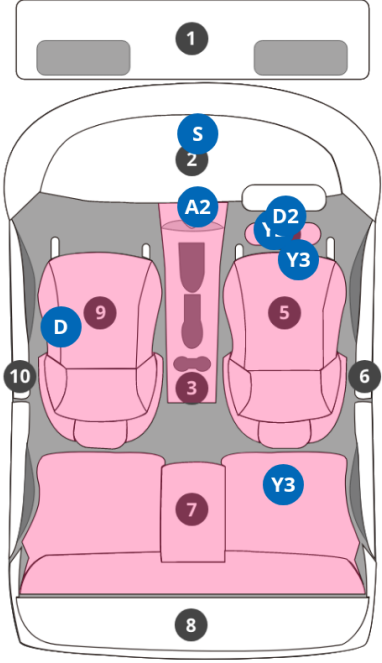
| Interior Evaluation : <b>B</b> | Exterior Evaluation : <b>E</b> |
| <p><b>Remarks</b><br/> Rear Seat - Grime - Medium / (R) Front Seat - Grime - Medium / (R) Front Floor Mat - Grime - Small / (L) Front Floor Mat - Worked - Small / (L) Front Seat - Worn - Yes / Console, Switches, Vents - Worn, Scratch, Cut, Crack - Small / Overall Interior - Smell - Yes</p> | <p><b>Remarks</b><br/> (R) Front Fender, Molding - Scratch - Small / (R) Mirror - Scratch - Small / (R) Front Door, Molding - Scratch - Large / (R) Rear Door, Molding - Scratch &amp; Dent - Large / (R) Rear Fender, Molding - Scratch - Small / Rear Bumper, Lamps, Panels - Scratch - Medium / (L) Front Door, Molding - Scratch &amp; Dent - Medium / (L) Front Fender, Molding - Scratch &amp; Dent - Medium / Trunk Hood, Rear Gate - Scratch - Large / (L) Step, In-panel, Side Spoiler - Scratch - Small / (L) Mirror - Scratch - Small / Front Bumper, Grille, Lamps - Scratch - Medium / Bonnet, Headlight - Scratch - Minimal / Roof - Scratch - Small / (L) Rear Fender, Molding - Scratch - Minimal / (L) Rear Door, Molding - Scratch - Minimal</p> |
