General Information

Make	Toyota	Model	Hilux
YOM	2023	Odo Meter Reading	80,723
Registration No.	BAF4169	Chassis No.	MR0AB8DDXP5036108
CC	2.4	Transmission	A/T
Fuel Type	Diesel	Type of Body	Pickup
Colour	Gray

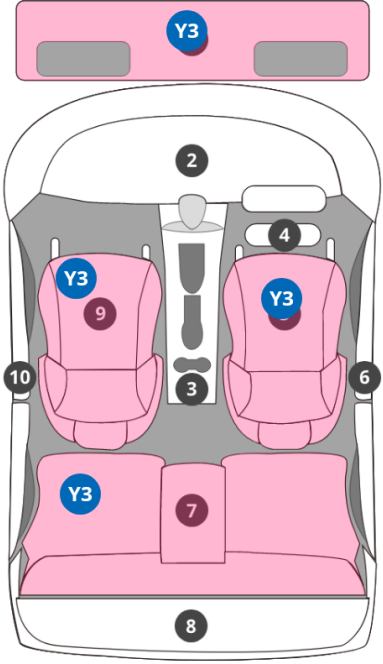
Interior Evaluation : B	Exterior Evaluation : D

<p>a : Cut, Fray d : Loose, Deformed k : Animal Hair s : Smell t : Cigarette Burns x : Defective y : Stain</p>

<p>A : Scratch AU : Scratch & Dent B : Modified C : Corrosion G : Stone chip P : Faded S : Rust SC : Rust & Corrosion U : Dent X : Defective Y : Crack, Gap</p>
<p>Remarks Ceiling - Grime - Medium / (R) Front Seat - Grime - Medium / Rear Seat - Grime - Medium / (L) Front Seat - Grime - Medium</p>	<p>Remarks (L) Mirror - Scratch - Minimal / Rear Gate - Dent - Medium / (R) Side Gate - Scratch - Medium / (R) Rear Door, Molding - Scratch - Small / Front Bumper, Grille, Lamps - Scratch & Dent - Medium / Roof - Scratch - Minimal / (L) Front Fender, Molding - Scratch - Small / (L) Rear Door, Molding - Scratch & Dent - Small / (L) Front Door, Molding - Scratch - Small / (L) Side Gate - Scratch & Dent - Medium / Cab Back Panel - Scratch - Small / Rear Bumper, Lamps, Panels - Scratch - Small / (R) Front Fender, Molding - Scratch - Small / (L) Center Panel - Scratch - Medium</p>
