## General Information

<b>Make</b>	Toyota	<b>Model</b>	Vios
<b>YOM</b>	2025	<b>Odo Meter Reading</b>	32,694
<b>Registration No.</b>	NEY4822	<b>Chassis No.</b>	PA1B18F34R4266430
<b>CC</b>	1.3	<b>Transmission</b>	CVT
<b>Fuel Type</b>	Gas	<b>Type of Body</b>	Sedan
<b>Colour</b>	Black

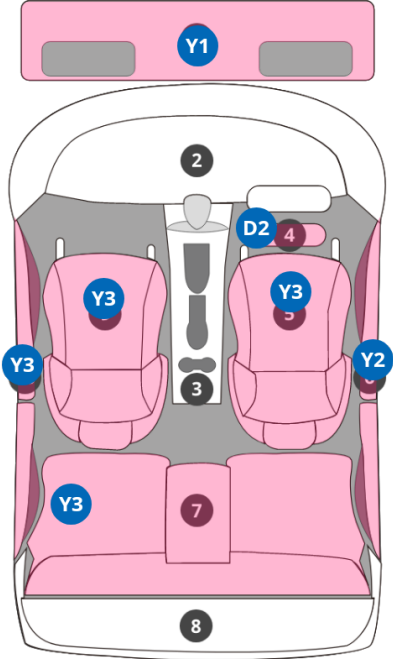
<b>Interior Evaluation :</b> <span style="float: right; color: red; font-weight: bold;">C</span>	<b>Exterior Evaluation :</b> <span style="float: right; color: red; font-weight: bold;">C</span>

<p><b>a</b> : Cut, Fray <b>d</b> : Loose, Deformed <b>k</b> : Animal Hair <b>s</b> : Smell <b>t</b> : Cigarette Burns <b>x</b> : Defective <b>y</b> : Stain</p>

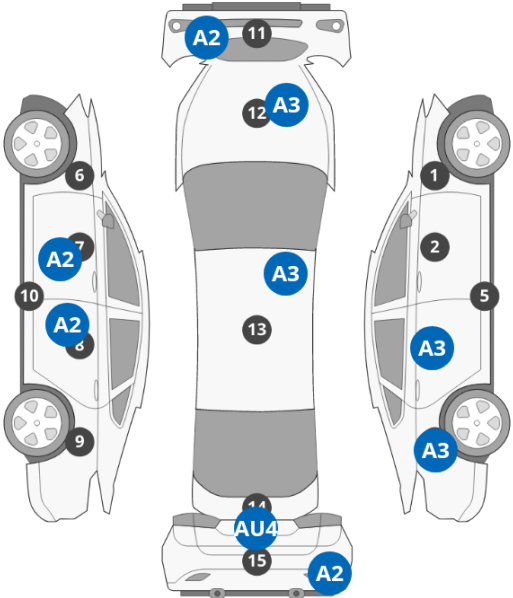
<p><b>A</b> : Scratch <b>AU</b> : Scratch &amp; Dent <b>B</b> : Modified <b>C</b> : Corrosion <b>G</b> : Stone chip <b>P</b> : Faded <b>S</b> : Rust <b>SC</b> : Rust &amp; Corrosion <b>U</b> : Dent <b>X</b> : Defective <b>Y</b> : Crack, Gap</p>
<p><b>Remarks</b> Ceiling - Grime - Minimal / (R) Front Trim - Grime - Small / (R) Front Seat - Grime - Medium / Rear Seat - Grime - Medium / (L) Front Trim - Grime - Medium / (L) Front Seat - Grime - Medium / (L) Front Floor Mat - Worked - Small</p>	<p><b>Remarks</b> Trunk Hood, Rear Gate - Scratch &amp; Dent - Large / Rear Bumper, Lamps, Panels - Scratch - Small / (R) Rear Fender, Molding - Scratch - Medium / (R) Rear Door, Molding - Scratch - Medium / Bonnet, Headlight - Scratch - Medium / (L) Rear Door, Molding - Scratch - Small / (L) Front Door, Molding - Scratch - Small / Front Bumper, Grille, Lamps - Scratch - Small / Roof - Scratch - Medium</p>
