## General Information

| Make | Toyota | Model | Vios |

## Body / Panel Condition

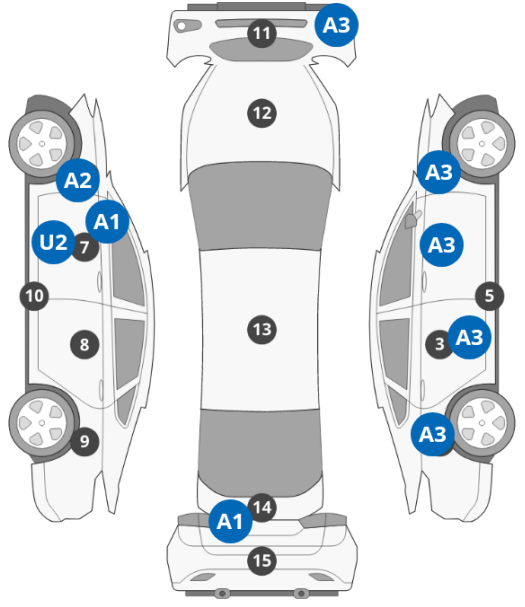
| <b>Remarks</b><br>(L) Front Floor Lag - Cut, Crack - Small | <b>Remarks</b><br>Front Bumper, Grille, Lamps - Scratch - Medium / (L) Front Fender, Molding - Scratch - Small / (L) Mirror - Scratch - Minimal / (L) Front Door, Molding - Dent - Small / Trunk Hood, Rear Gate - Scratch - Minimal / (R) Rear Fender, Molding - Scratch - Medium / (R) Rear Door, Molding - Scratch - Medium / (R) Front Door, Molding - Scratch - Medium / (R) Front Fender, Molding - Scratch - Medium |

| Inspector Notes |
|---|
| hairline scratches around the exterior. |
