## General Information

<b>Make</b>	Toyota	<b>Model</b>	Vios
<b>YOM</b>	2025	<b>Odo Meter Reading</b>	11,362
<b>Registration No.</b>	NKE9344	<b>Chassis No.</b>	PA1B18F34R4265102
<b>CC</b>	1.3	<b>Transmission</b>	CVT
<b>Fuel Type</b>	Gas	<b>Type of Body</b>	Sedan
<b>Colour</b>	Blackish Red Mica

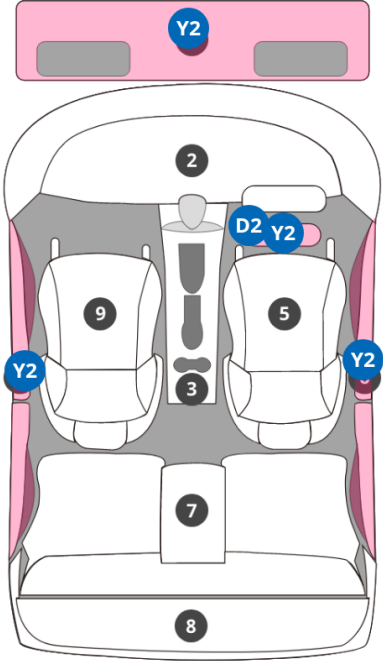
<b>Interior Evaluation :</b> <span style="float: right;"><b>B</b></span>	<b>Exterior Evaluation :</b> <span style="float: right;"><b>B</b></span>

<p><b>a</b> : Cut, Fray <b>d</b> : Loose, Deformed <b>k</b> : Animal Hair <b>s</b> : Smell <b>t</b> : Cigarette Burns <b>x</b> : Defective <b>y</b> : Stain</p>

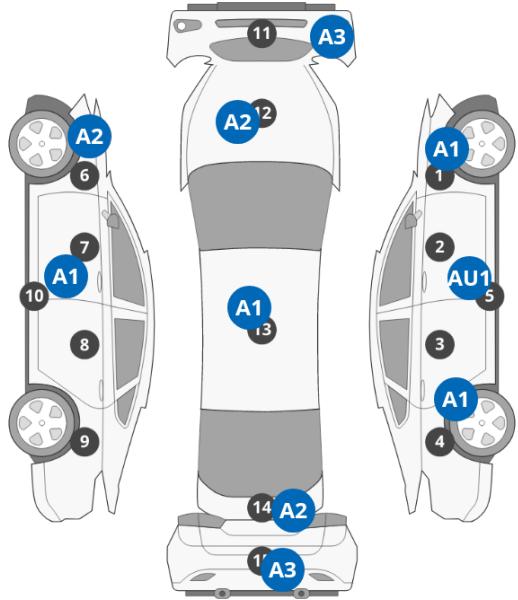
<p><b>A</b> : Scratch <b>AU</b> : Scratch &amp; Dent <b>B</b> : Modified <b>C</b> : Corrosion <b>G</b> : Stone chip <b>P</b> : Faded <b>S</b> : Rust <b>SC</b> : Rust &amp; Corrosion <b>U</b> : Dent <b>X</b> : Defective <b>Y</b> : Crack, Gap</p>
<p><b>Remarks</b> Ceiling - Grime - Small / (R) Front Trim - Grime - Small / Mat Other - Grime - Small / (L) Front Trim - Grime - Small / (L) Front Floor Mat - Worked - Small</p>	<p><b>Remarks</b> Front Bumper, Grille, Lamps - Scratch - Medium / (R) Front Fender, Molding - Scratch - Minimal / (R) Front Door, Molding - Scratch &amp; Dent - Minimal / (R) Rear Fender, Molding - Scratch - Minimal / Rear Bumper, Lamps, Panels - Scratch - Medium / Trunk Hood, Rear Gate - Scratch - Small / (L) Front Door, Molding - Scratch - Minimal / (L) Front Fender, Molding - Scratch - Small / Bonnet, Headlight - Scratch - Small / Roof - Scratch - Minimal</p>
