## General Information

<b>Make</b>	Toyota	<b>Model</b>	Vios
<b>YOM</b>	2025	<b>Odo Meter Reading</b>	16,804
<b>Registration No.</b>	NKF7838	<b>Chassis No.</b>	PA1B18F31R4270368
<b>CC</b>	1.3	<b>Transmission</b>	CVT
<b>Fuel Type</b>	Gas	<b>Type of Body</b>	Sedan
<b>Colour</b>	Black

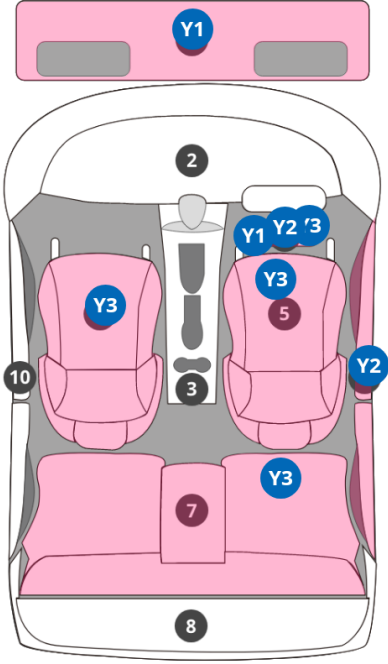
<b>Interior Evaluation :</b> <span style="float: right;"><b>C</b></span>	<b>Exterior Evaluation :</b> <span style="float: right;"><b>C</b></span>

<p><b>a</b> : Cut, Fray <b>d</b> : Loose, Deformed <b>k</b> : Animal Hair <b>s</b> : Smell <b>t</b> : Cigarette Burns <b>x</b> : Defective <b>y</b> : Stain</p>

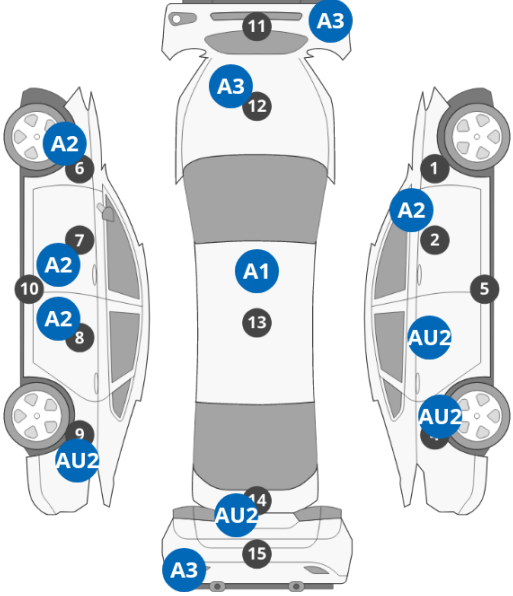
<p><b>A</b> : Scratch <b>AU</b> : Scratch &amp; Dent <b>B</b> : Modified <b>C</b> : Corrosion <b>G</b> : Stone chip <b>P</b> : Faded <b>S</b> : Rust <b>SC</b> : Rust &amp; Corrosion <b>U</b> : Dent <b>X</b> : Defective <b>Y</b> : Crack, Gap</p>
<p><b>Remarks</b> Ceiling - Grime - Minimal / (R) Front Trim - Grime - Small / (R) Front Seat - Grime - Medium / (R) Front Floor Mat - Grime - Medium / Rear Seat - Grime - Medium / Mat Other - Grime - Small / (L) Front Seat - Grime - Medium / (L) Front Floor Mat - Grime - Minimal</p>	<p><b>Remarks</b> (L) Rear Fender, Molding - Scratch &amp; Dent - Small / (L) Front Door, Molding - Scratch - Small / (L) Rear Door, Molding - Scratch - Small / (L) Front Fender, Molding - Scratch - Small / Front Bumper, Grille, Lamps - Scratch - Medium / Bonnet, Headlight - Scratch - Medium / (R) Rear Fender, Molding - Scratch &amp; Dent - Small / (R) Mirror - Scratch - Small / Trunk Hood, Rear Gate - Scratch &amp; Dent - Small / Rear Bumper, Lamps, Panels - Scratch - Medium / Roof - Scratch - Minimal / (R) Rear Door, Molding - Scratch &amp; Dent - Small</p>
