General Information

Make	Toyota	Model	Innova
YOM	2025	Odo Meter Reading	64,158
Registration No.	BAG7535	Chassis No.	PA2JA8EM6R0148503
CC	2.8	Transmission	A/T
Fuel Type	Diesel	Type of Body	MPV
Colour	Red Mica Metallic

Body / Panel Condition

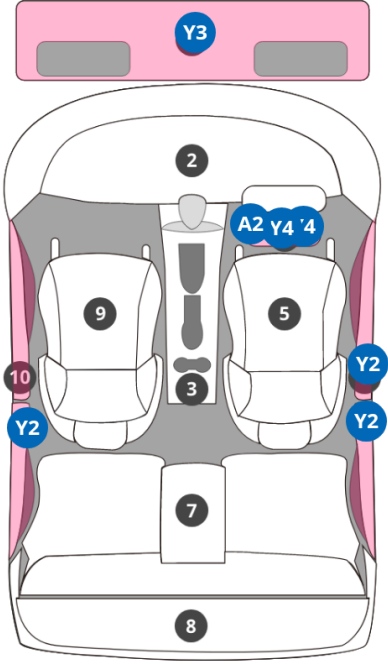
Interior Evaluation : C	Exterior Evaluation : D

<p>a : Cut, Fray d : Loose, Deformed k : Animal Hair s : Smell t : Cigarette Burns x : Defective y : Stain</p>

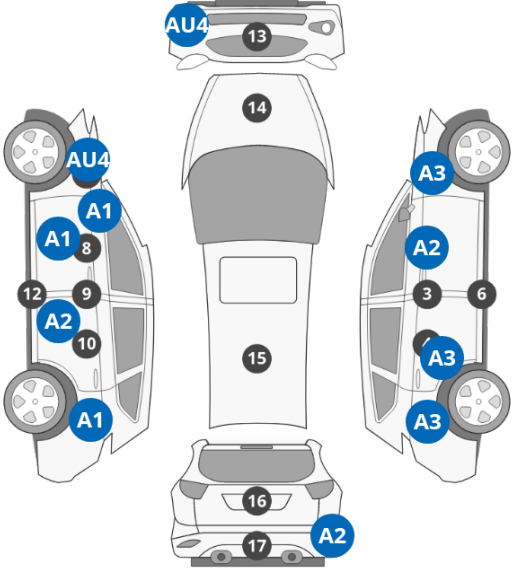
<p>A : Scratch AU : Scratch & Dent B : Modified C : Corrosion G : Stone chip P : Faded S : Rust SC : Rust & Corrosion U : Dent X : Defective Y : Crack, Gap</p>
<p>Remarks Ceiling - Grime - Medium / (R) Front Floor Mat - Grime - Large / (R) Front Trim - Grime - Small / (R) Rear Trim - Grime - Small / Mat Other - Grime - Large / (L) Rear Trim - Grime - Small / (L) Front Floor Mat - Cut, Crack - Small</p>	<p>Remarks (L) Front Fender, Molding - Scratch & Dent - Large / Front Bumper, Grille, Lamps - Scratch & Dent - Large / (R) Front Fender, Molding - Scratch - Medium / (R) Rear Door, Molding - Scratch - Medium / (R) Front Door, Molding - Scratch - Small / (R) Rear Fender, Molding - Scratch - Medium / Rear Bumper, Lamps, Panels - Scratch - Small / (L) Rear Fender, Molding - Scratch - Minimal / (L) Rear Door, Molding - Scratch - Small / (L) Mirror - Scratch - Minimal / (L) Front Door, Molding - Scratch - Minimal</p>
