## General Information

<b>Make</b>	Toyota	<b>Model</b>	Vios
<b>YOM</b>	2025	<b>Odo Meter Reading</b>	6,130
<b>Registration No.</b>	BAG7277	<b>Chassis No.</b>	PA1B18F36R4279051
<b>CC</b>	1.3	<b>Transmission</b>	CVT
<b>Fuel Type</b>	Gas	<b>Type of Body</b>	Sedan
<b>Colour</b>	Blue

## Body / Panel Condition

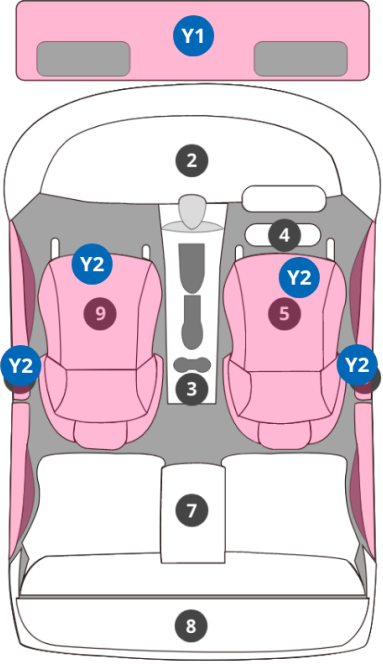
<b>Interior Evaluation :</b> <span style="float: right;"><b>B</b></span>	<b>Exterior Evaluation :</b> <span style="float: right;"><b>C</b></span>

<p><b>a</b> : Cut, Fray <b>d</b> : Loose, Deformed <b>k</b> : Animal Hair <b>s</b> : Smell <b>t</b> : Cigarette Burns <b>x</b> : Defective <b>y</b> : Stain</p>

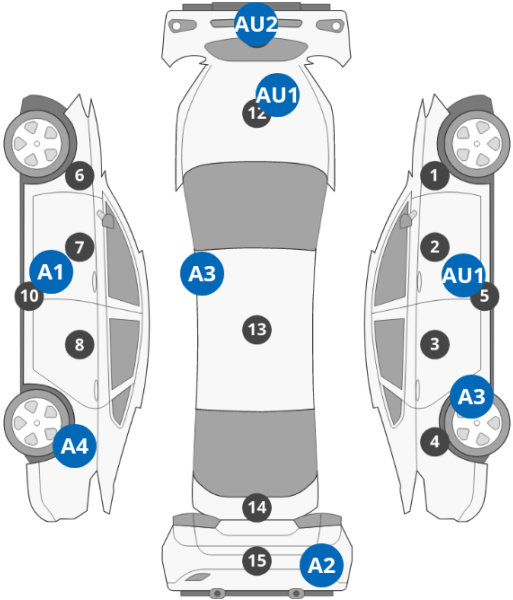
<p><b>A</b> : Scratch <b>AU</b> : Scratch &amp; Dent <b>B</b> : Modified <b>C</b> : Corrosion <b>G</b> : Stone chip <b>P</b> : Faded <b>S</b> : Rust <b>SC</b> : Rust &amp; Corrosion <b>U</b> : Dent <b>X</b> : Defective <b>Y</b> : Crack, Gap</p>
<p><b>Remarks</b> Ceiling - Grime - Minimal / (R) Front Trim - Grime - Small / (R) Front Seat - Grime - Small / (L) Front Seat - Grime - Small / (L) Front Trim - Grime - Small</p>	<p><b>Remarks</b> Bonnet, Headlight - Scratch &amp; Dent - Minimal / (R) Front Door, Molding - Scratch &amp; Dent - Minimal / (R) Rear Fender, Molding - Scratch - Medium / Rear Bumper, Lamps, Panels - Scratch - Small / (L) Rear Fender, Molding - Scratch - Large / (L) Front Door, Molding - Scratch - Minimal / Front Bumper, Grille, Lamps - Scratch &amp; Dent - Small / Roof - Scratch - Medium</p>
