General Information

Make	Hyundai	Model	Kona
YOM	2020	Odo Meter Reading	30,132
Registration No.	HAB7674	Chassis No.	KMHK381ABKU454722
CC	2.0	Transmission	A/T
Fuel Type	Gas	Type of Body	SUV
Colour	Red

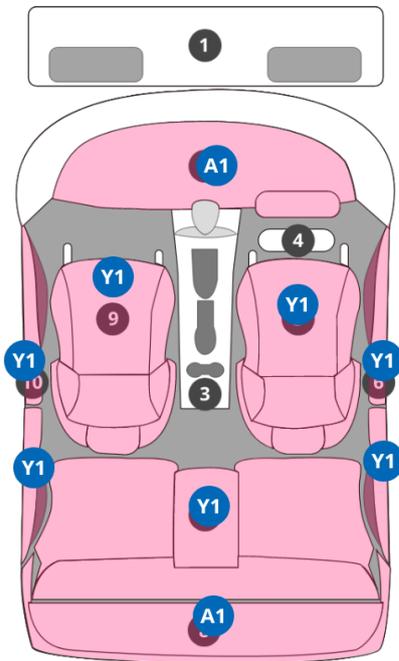
Interior Evaluation : A	Exterior Evaluation : D

<p>a : Cut, Fray d : Loose, Deformed k : Animal Hair s : Smell t : Cigarette Burns x : Defective y : Stain</p>

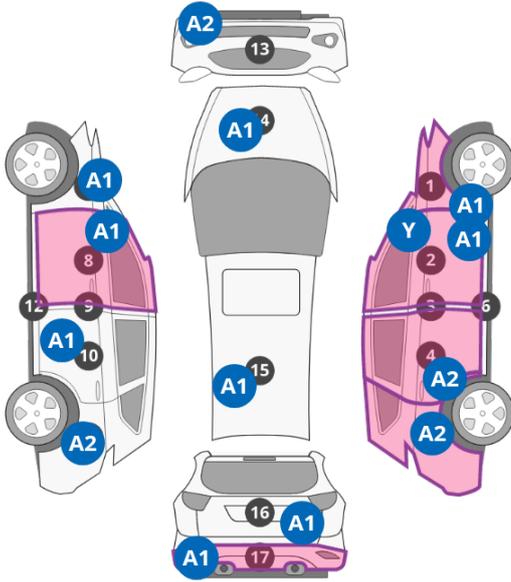
<p>A : Scratch AU : Scratch & Dent B : Modified C : Corrosion G : Stone chip P : Faded S : Rust SC : Rust & Corrosion U : Dent X : Defective Y : Crack, Gap</p>
<p>Remarks Trunk Room - Worn, Scratch, Cut, Crack - Minimal / (R) Rear Trim - Grime - Minimal / (L) Rear Trim - Grime - Minimal / (R) Front Trim - Grime - Minimal / (L) Front Trim - Grime - Minimal / (R) Front Seat - Grime - Minimal / (L) Front Seat - Grime - Minimal / Dashboard - Worn, Scratch, Cut, Crack - Minimal / Rear Seat - Grime - Minimal</p>	<p>Remarks (R) Front Door - Repair Traces - Yes / (R) Front Fender - Repair Traces - Yes / (R) Rear Door - Repair Traces - Yes / (R) Front Fender, Molding - Repair mark - Yes / (R) Front Door, Molding - Repair mark - Yes / (R) Rear Door, Molding - Repair mark - Yes / (R) Rear Fender, Molding - Repair mark - Yes / (R) Front Fender, Molding - Scratch - Minimal / (R) Front Door, Molding - Scratch - Minimal / (R) Rear Door, Molding - Scratch - Small / (R) Rear Fender, Molding - Scratch - Small / Rear Bumper, Lamps, Panels - Repair mark - Yes / Trunk Hood, Rear Gate - Scratch - Minimal / Rear Bumper, Lamps, Panels - Scratch - Minimal / (L) Rear Fender, Molding - Scratch - Small / (L) Rear Door, Molding - Scratch - Minimal / (L) Mirror - Scratch - Minimal / (L) Front Door, Molding - Repair mark - Yes / (L) Front Fender, Molding - Scratch - Minimal / Front Bumper, Grille, Lamps - Scratch - Small / Bonnet, Headlight - Scratch - Minimal / Roof - Scratch - Minimal / (R) Mirror - Crack - Damaged</p>
